Property

649 Wood Dr.
Glenview, IL 60022

John Doe

02/01/2019 1:00 pm

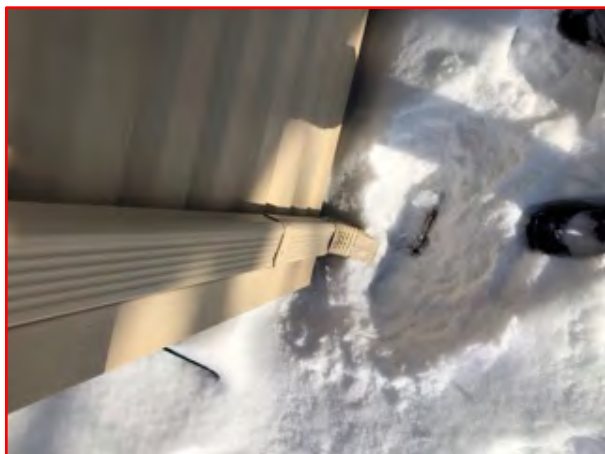
Figure 1-1

1) Downspouts should extend a min of 4-6' from the structure to reduce the risk of water penetration, settlement and structural damage. Evidence of water infiltration noted in crawlspace.

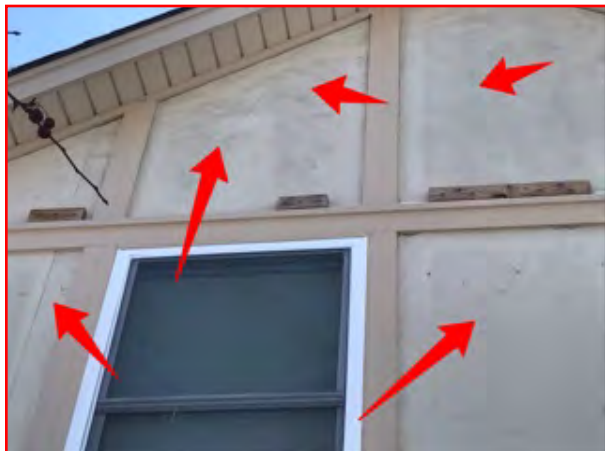
Figure 6-1

4) Damage to the front stucco and wood planks (2" x 4") are nailed to front stucco. We Recommend having a licensed professional to evaluate before closing. See attic section.

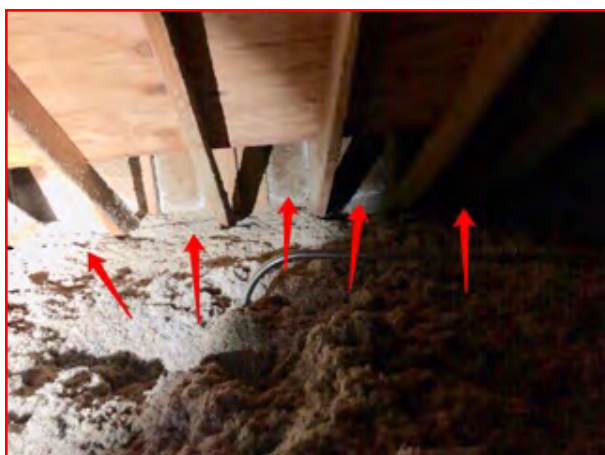
Figure 8-1

5) There is frost buildup on the front wall of the attic. Damage to the front exterior in this area has been temporarily repaired with 2x4 boards. We recommend the front of the home and this section of attic be evaluated for repair by a qualified building contractor to prevent further water damage.

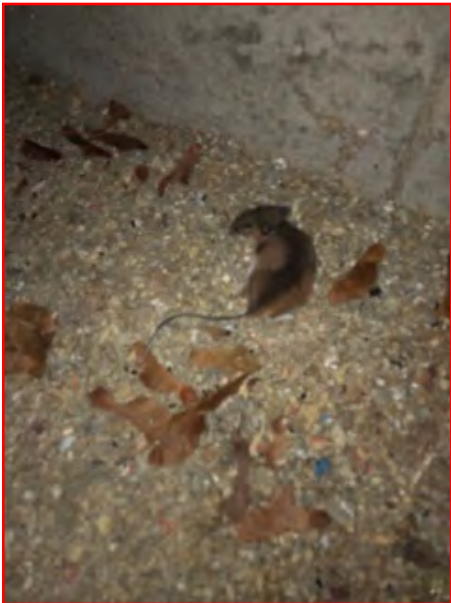
Figure 12-1

7) There is evidence of rodent activity. We recommend evaluation by a pest control professional.

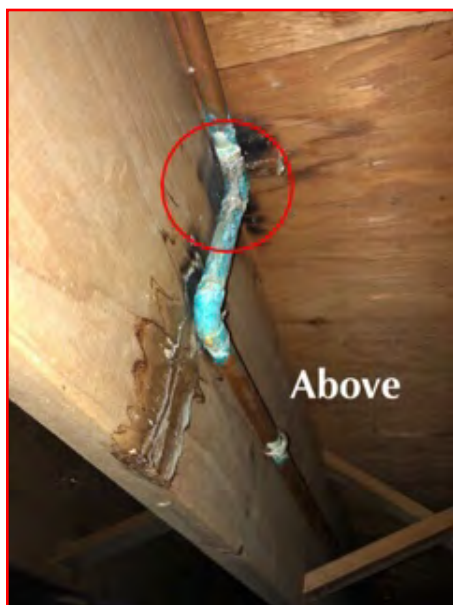
Figure 16-1

10) There is an active leak and heavy corrosion on a copper water supply pipe in the south central part of the crawlspace. We recommend all water supply fittings in the crawlspace be evaluated by a licensed plumber. Active leaks should be repaired promptly.

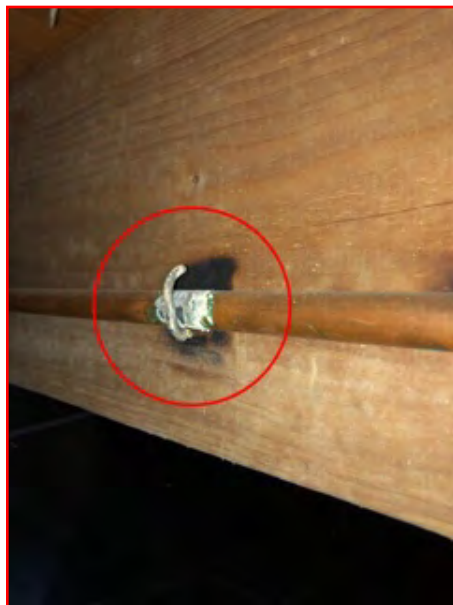
Figure 17-1

11) There is galvanic corrosion on the water pipes at numerous joints and fasteners. We recommend all visible water pipes be evaluated by a qualified plumber. Any improper hangers should be replaced with correct ones to reduce the risk of electrolysis and eventual leaks.

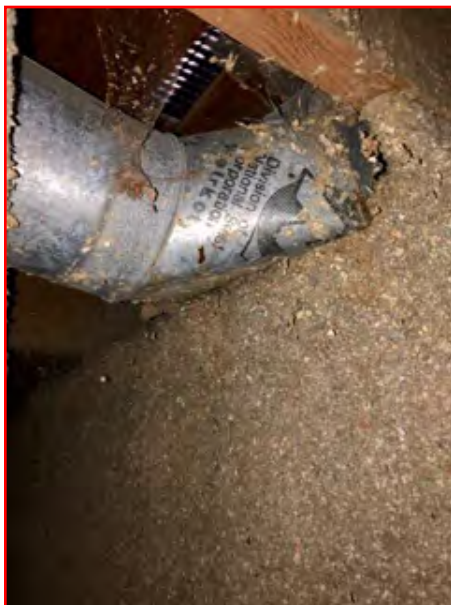
Figure 18-1

12) There are loose, poorly supported and uninsulated HVAC ducts in the crawlspace. Signs of water below ducts can indicate poor management of condensate runoff. We recommend ductwork be evaluated by a licensed HVAC professional. See comments on HVAC "distribution" section of report.

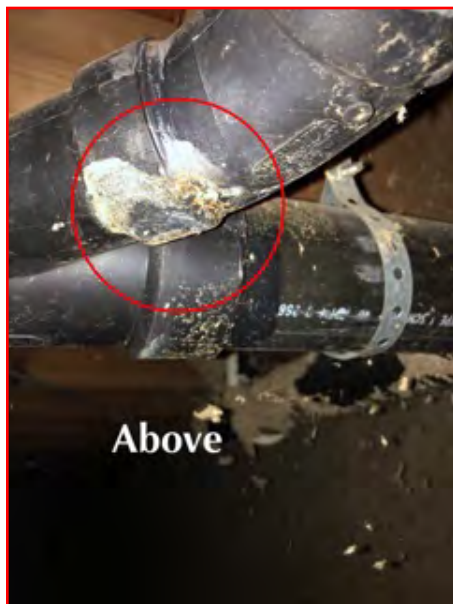
Figure 19-1

13) There is a leak at a union in the black waste line in the crawlspace. We recommend evaluation for repair by a qualified plumber.

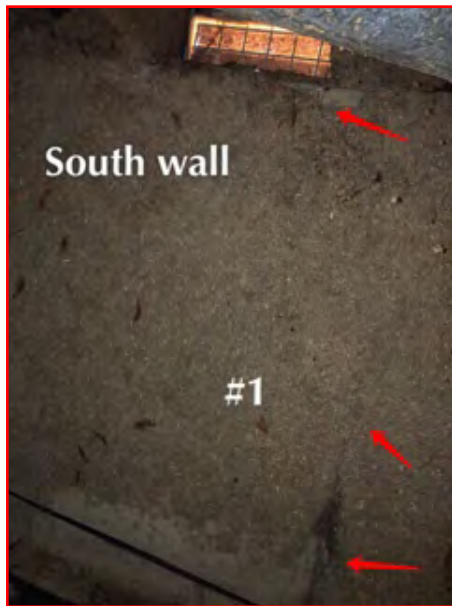
Figure 20-1

14) There are 3 or more cracks in the foundation. These should be evaluated for repair by a qualified basement waterproofing/structural professional.

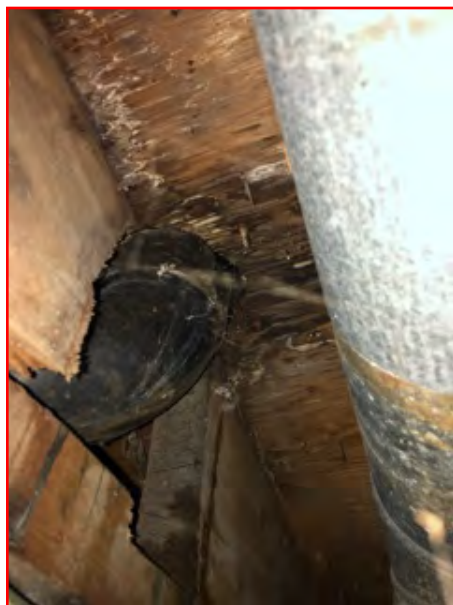
Figure 21-1

15) The main floor toilet is loose and leaking on to the HVAC ductwork below. We recommend repair by a qualified plumber and professional cleaning of the ductwork.

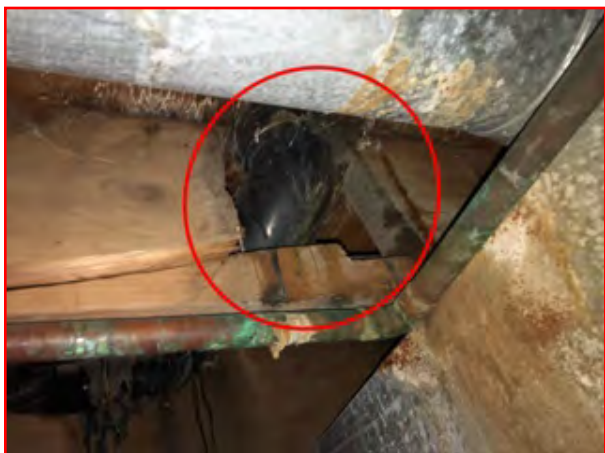
Figure 22-1

16) The joist below the main floor toilet has been improperly notched to accommodate the waste drain. The remaining joist has split through. This should be evaluated by a qualified building contractor prior to repairs of the toilet.

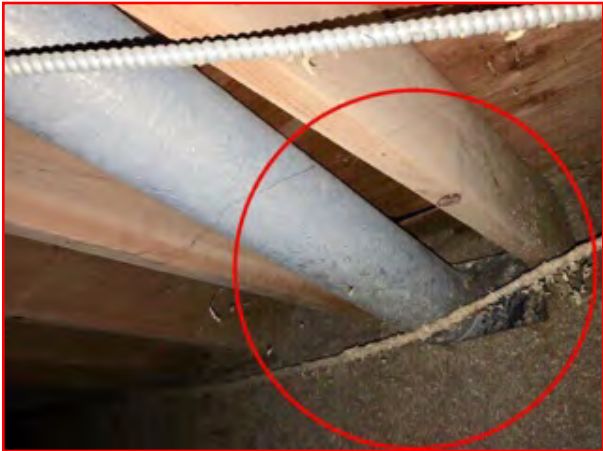
Figure 28-1

18) One of the supply ducts in the crawlspace is not correctly installed. Conditioned air is being supplied to the crawlspace rather than the kitchen heat register above. We recommend the ductwork in the crawl space be evaluated by a HVAC professional.

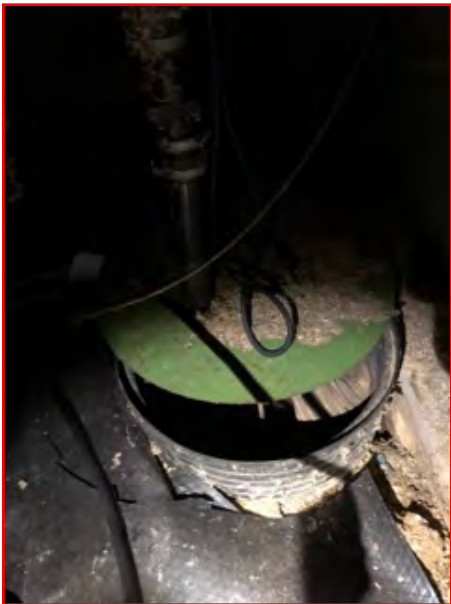
Figure 30-1

19) The check valve in the sump drain line is leaking.

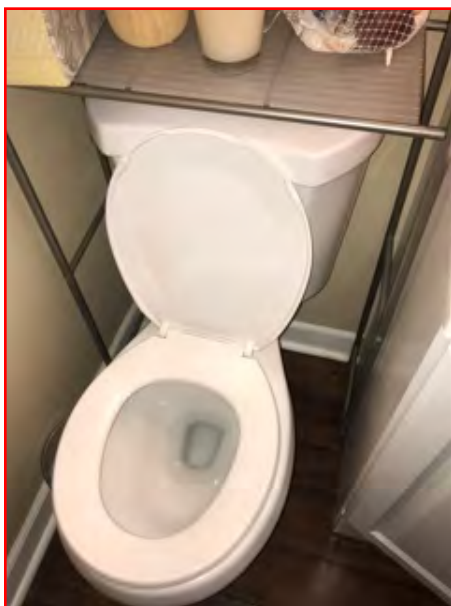
Figure 35-1

22) The toilet is loose at the floor and requires sealant at the base.

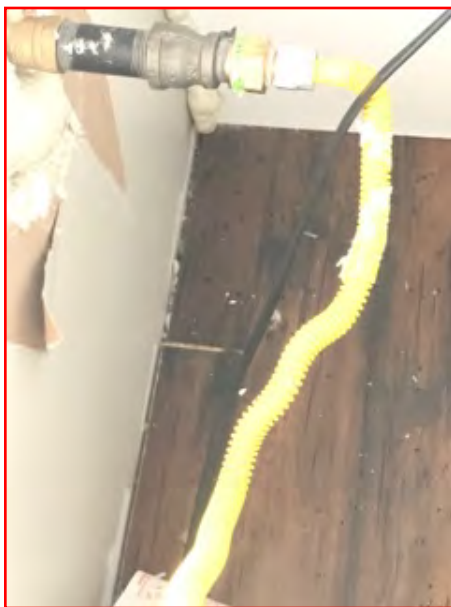
Figure 37-1

24) Signs of rodents /mice dropping behind the stove. Recommend having a licensed exterminator to evaluate.

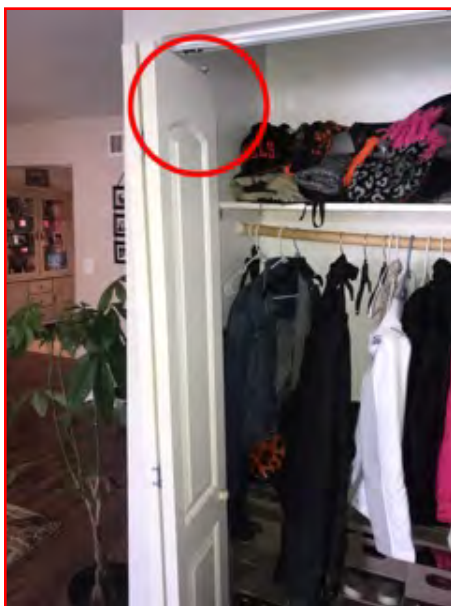
Figure 40-1

27) the closet folding doors are off their track and damaged.

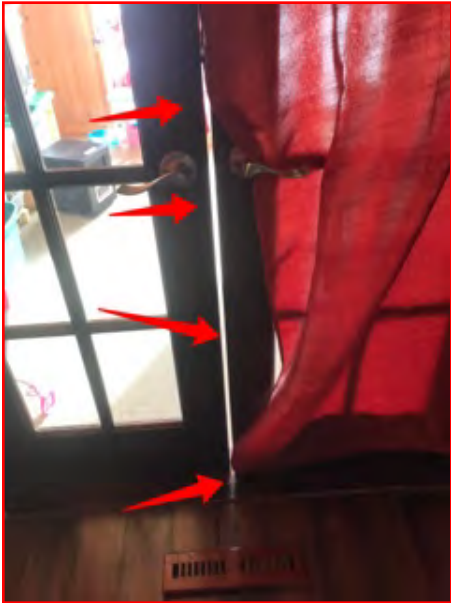
Figure 43-1

29) The french doors leading to sun room are interior doors with a large gap, allowing heat to escape to the sun room. The sun room is not heated nor has proper insulation. We recommend having a sealed exterior grade door to prevent the huge heat loss.

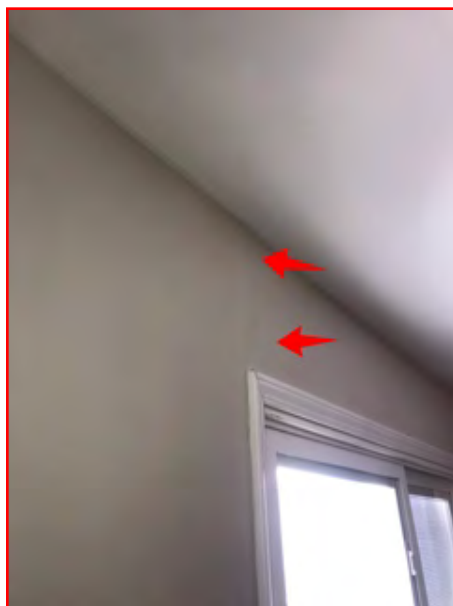
Figure 47-1

32) Settlement crack in the south wall.

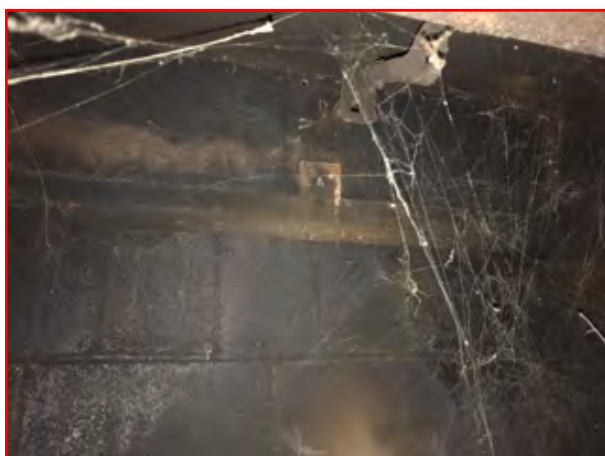
Figure 48-1

33) Recommend a professional to clean and evaluate the fireplace before usage. There is a build up of soot along the walls.

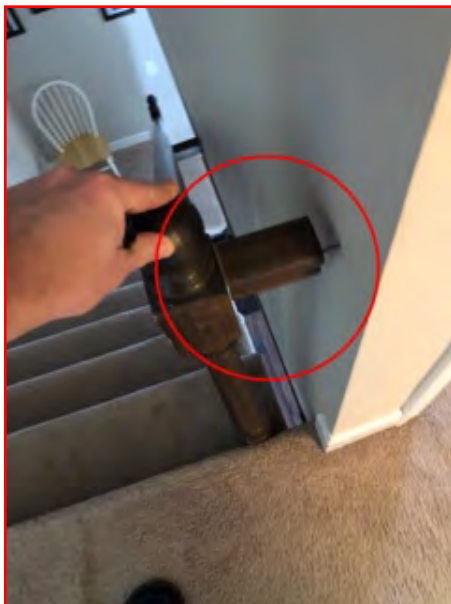
Figure 51-1

36) The handrail is loose.

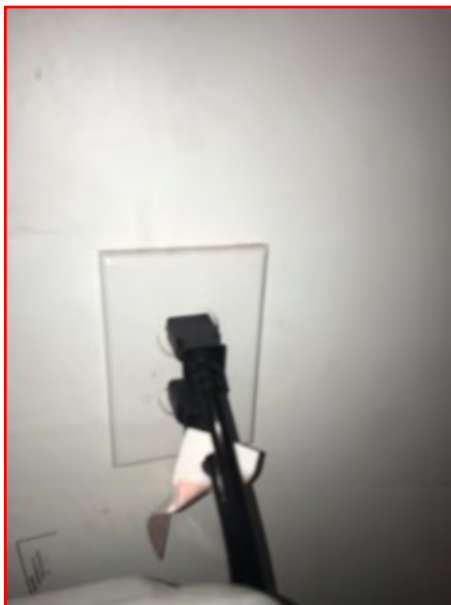
Figure 56-1

37) Ground fault circuit interrupter (GFCI) outlets needed in laundry area.

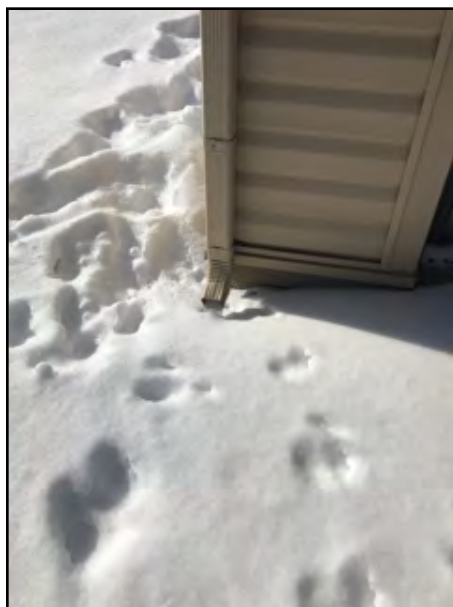
Figure 2-3

i Comment 2:
Downspout needs to be extended 6' away from the property to prevent water infiltrating the foundation.

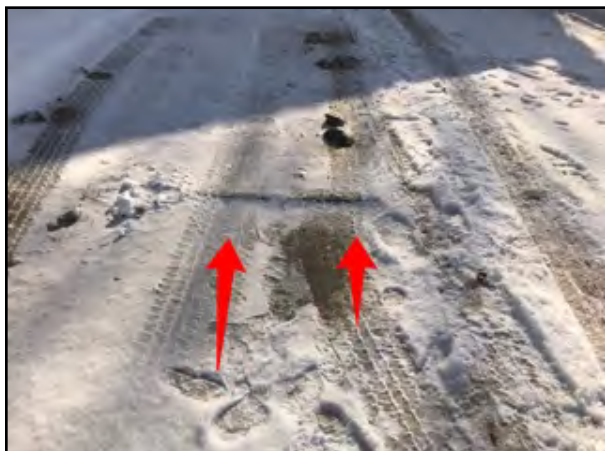
Figure 3-1

The driveway expansion joint that separates concrete slabs are not sealed properly. Resulting in movement of the slabs due to frost heaving and becoming a trip hazard.

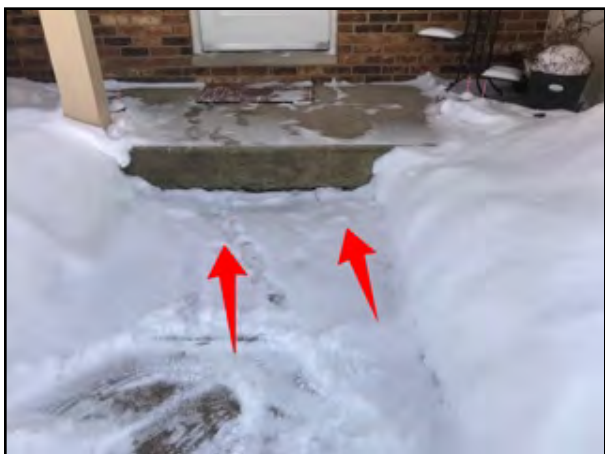
Figure 4-1

A negative grading in front walkway of the home is leading water towards the front stoop and foundation.

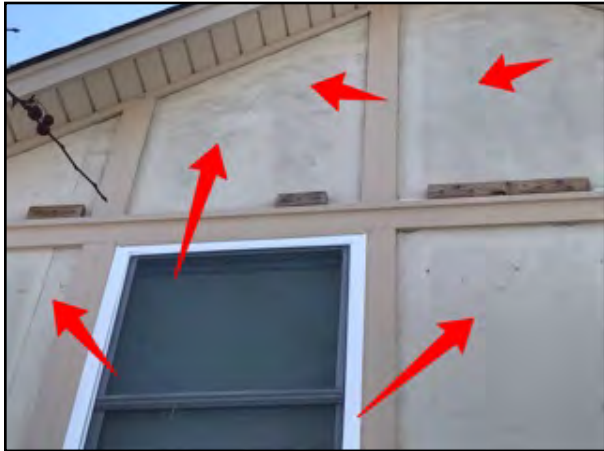
Figure 6-1

Damage to the front stucco and wood planks (2" x 4") are nailed to front stucco. We Recommend having a licensed professional to evaluate before closing. See attic section.

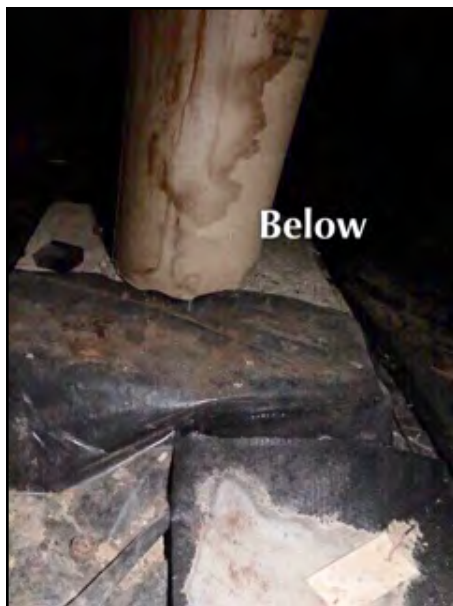
Figure 10-1

There is a saddle valve that is not in use. Saddle valves are commonly used for refrigerator ice maker water supply but they are inherently unreliable. There is evidence of past water leaks below. Area was dry at the time of the inspection.

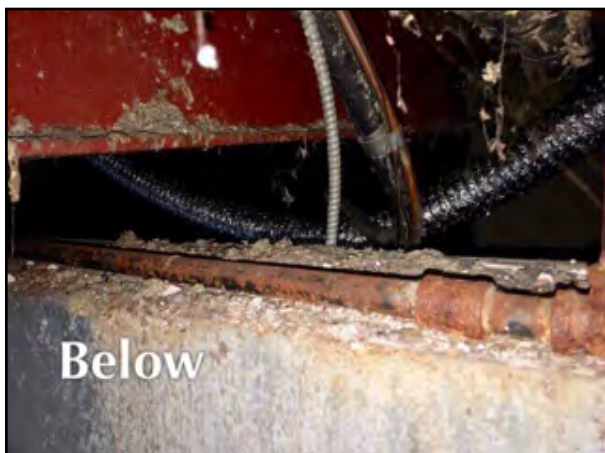
Figure 11-1

There is a rusty gas pipe and evidence of a past water leak. Dry when inspected.

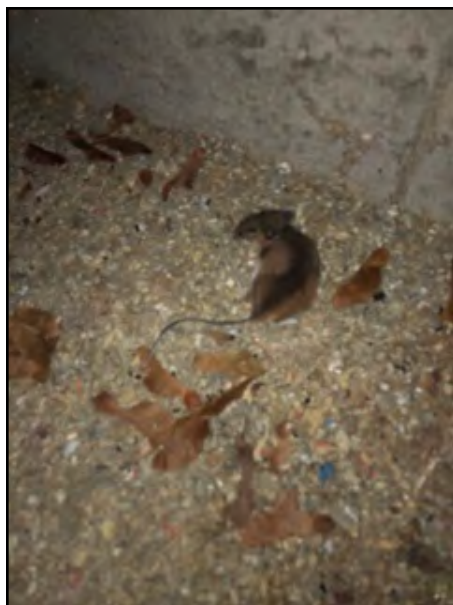
Figure 12-1

There is evidence of rodent activity. We recommend evaluation by a pest control professional.

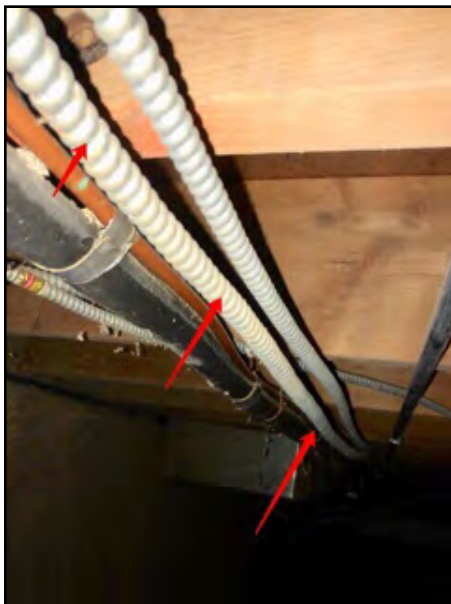
Figure 14-1

There are lengths of armored (BX) electrical wires that are not properly supported. We recommend electrical branch wiring in the crawlspace be evaluated by a qualified electrician.

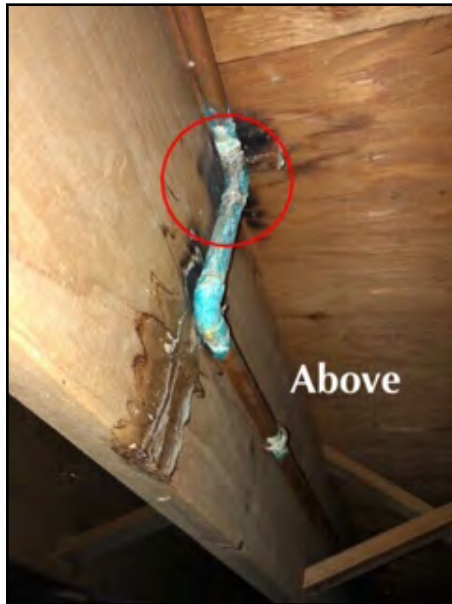
Figure 16-1

There is an active leak and heavy corrosion on a copper water supply pipe in the south central part of the crawlspace. We recommend all water supply fittings in the crawlspace be evaluated by a licensed plumber. Active leaks should be repaired promptly.

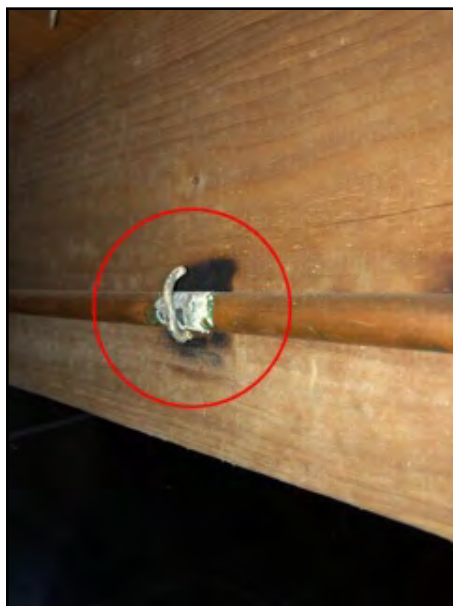
Figure 17-1

There is galvanic corrosion on the water pipes at numerous joints and fasteners. We recommend all visible water pipes be evaluated by a qualified plumber. Any improper hangers should be replaced with correct ones to reduce the risk of electrolysis and eventual leaks.

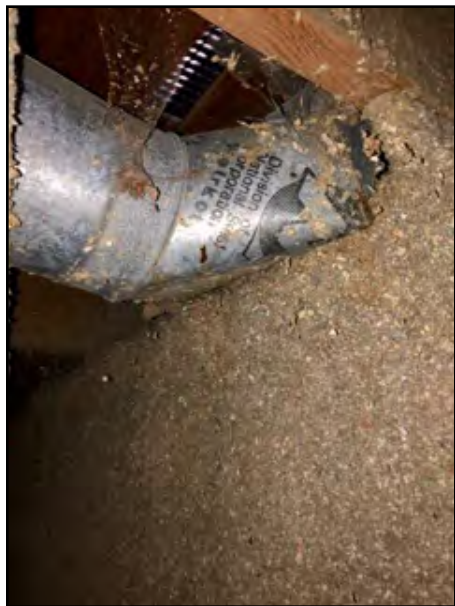
Figure 18-1

There are loose, poorly supported and uninsulated HVAC ducts in the crawlspace. Signs of water below ducts can indicate poor management of condensate runoff. We recommend ductwork be evaluated by a licensed HVAC professional. See comments on HVAC "distribution" section of report.

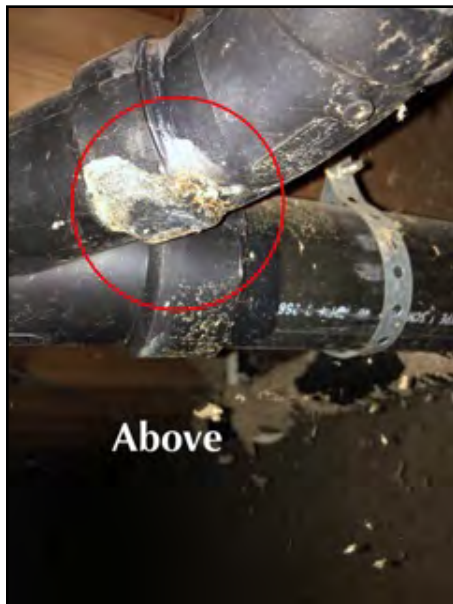
Figure 19-1

There is a leak at a union in the black waste line in the crawlspace. We recommend evaluation for repair by a qualified plumber.

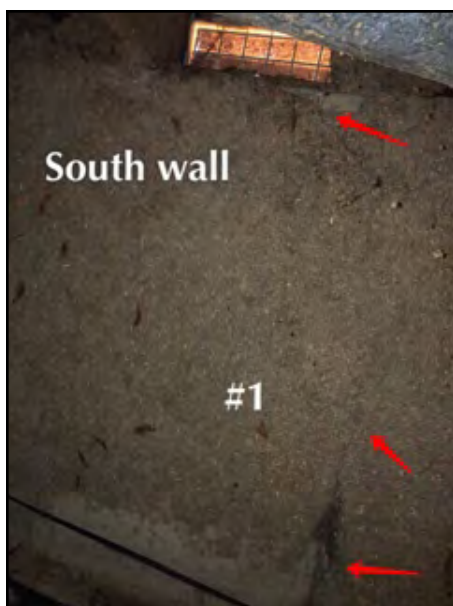
Figure 20-1

There are 3 or more cracks in the foundation. These should be evaluated for repair by a qualified basement waterproofing/structural professional.

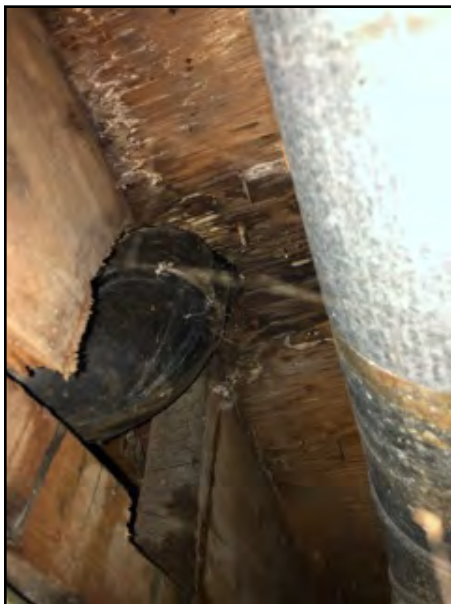
Figure 21-1

The main floor toilet is loose and leaking on to the HVAC ductwork below. We recommend repair by a qualified plumber and professional cleaning of the ductwork.

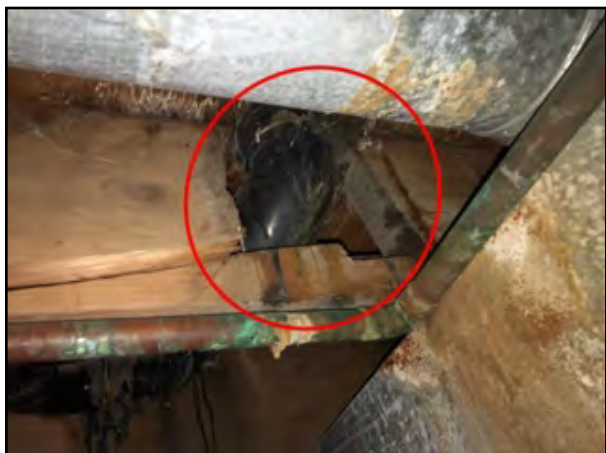
Figure 22-1

The joist below the main floor toilet has been improperly notched to accommodate the waste drain. The remaining joist has split through. This should be evaluated by a qualified building contractor prior to repairs of the toilet.

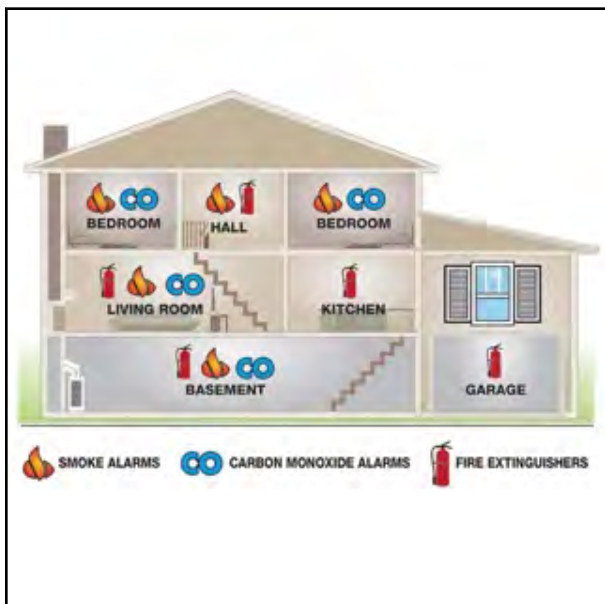
Figure 26-1

Due to the limited life span of detectors and unknown age of current equipment, we recommend installing new CO detectors on every floor and new Smoke detectors on every floor and in every bedroom upon taking possession.

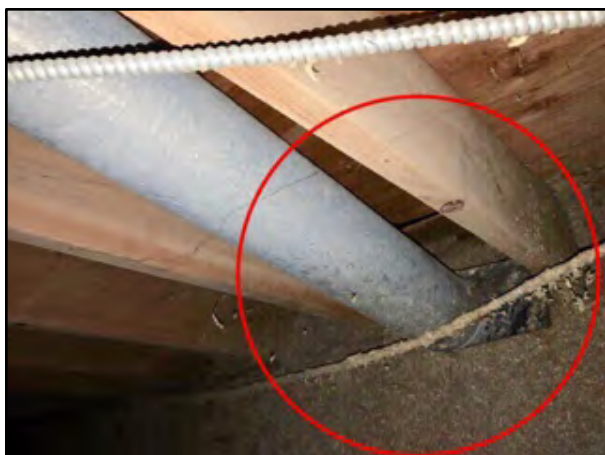
Figure 28-1

One of the supply ducts in the crawlspace is not correctly installed. Conditioned air is being supplied to the crawlspace rather than the kitchen heat register above. We recommend the ductwork in the crawl space be evaluated by a HVAC professional.

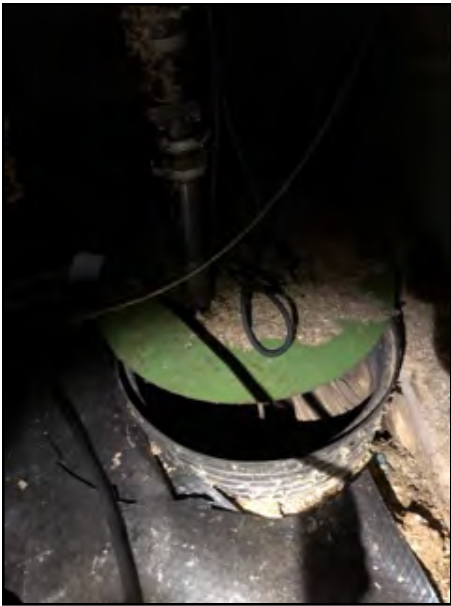
Figure 30-1

Comment 30:
The check valve in the sump drain line is leaking.

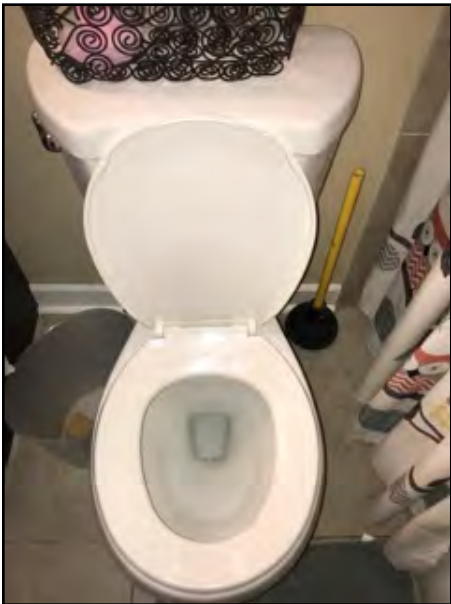
Figure 34-1

The toilet is loose at the floor and requires sealant at the base.

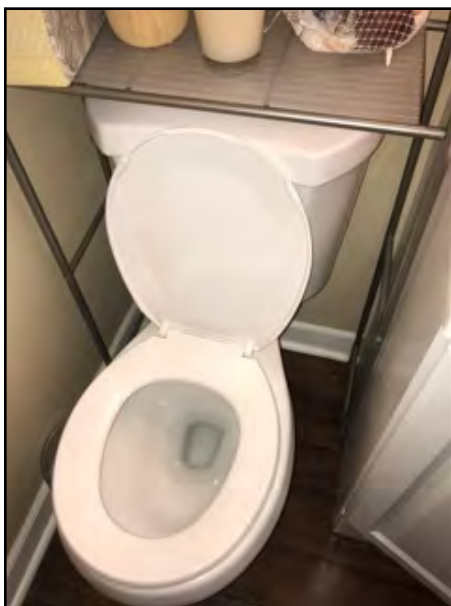
Figure 35-1

The toilet is loose at the floor and requires sealant at the base.

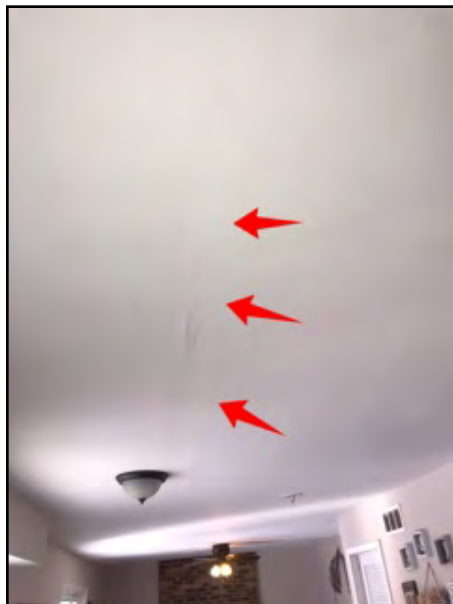
Figure 38-1

**Comment 38:**
Settlement crack with signs of past moisture along the tapping of the ceiling drywall.

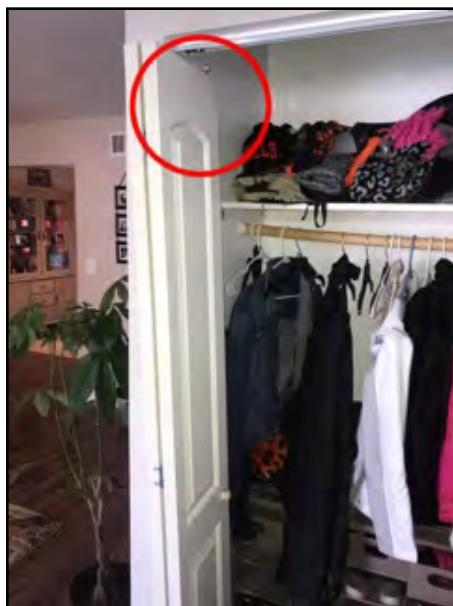
Figure 40-1

Comment 40:
the closet folding doors are off their track and damaged.

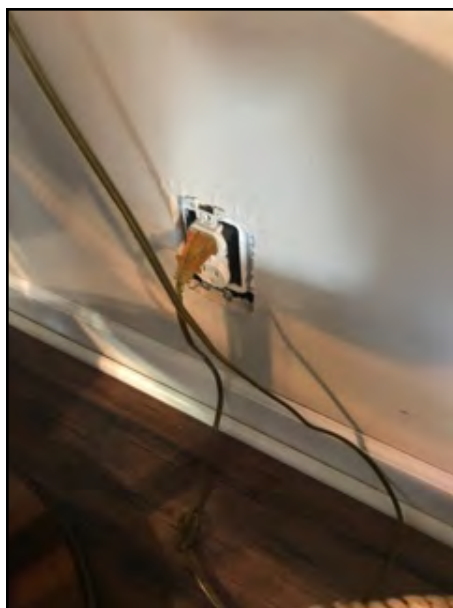
Figure 41-1

Comment 41:
East wall outlet is missing a cover plate.

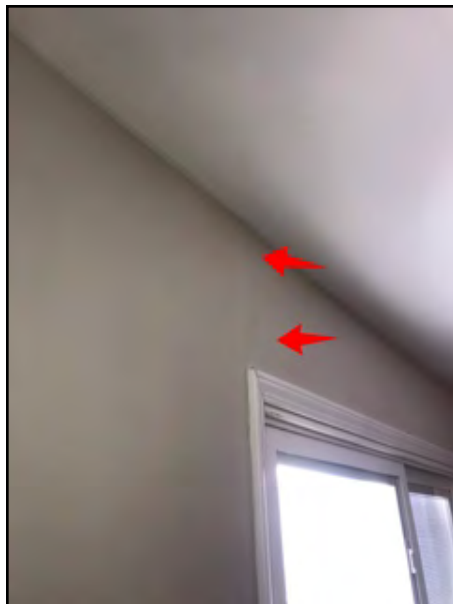
Figure 47-1

Comment 47:
Settlement crack in the south wall.

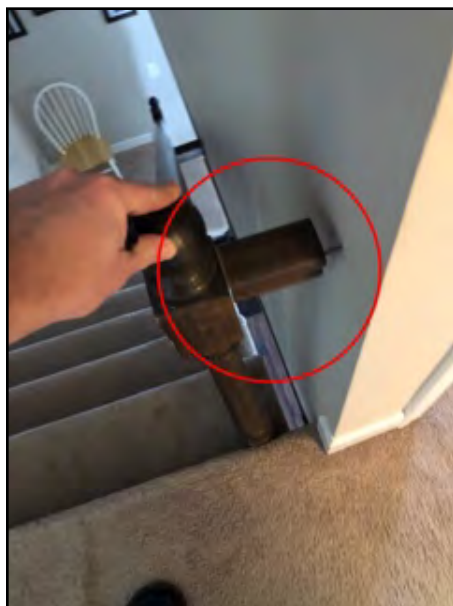
Figure 51-1

Comment 51:
The handrail is loose.

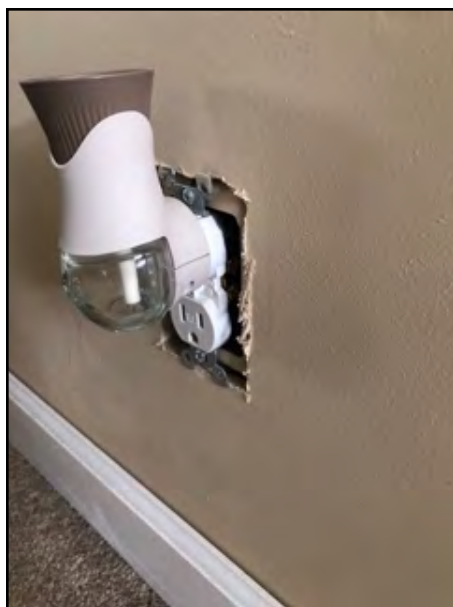
Figure 52-1

Comment 52:
There are missing switch plates.

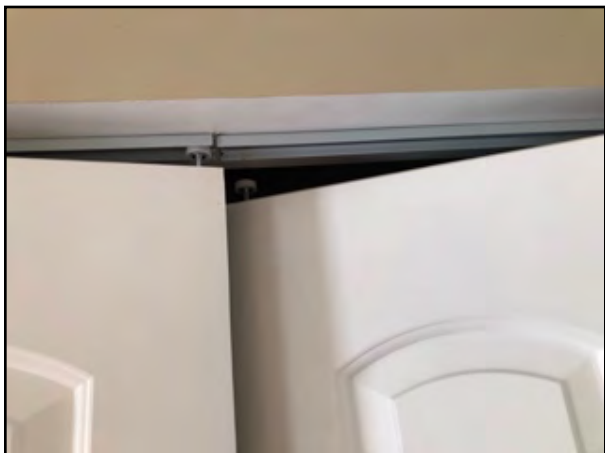
Figure 55-1

Comment 55:
The closet doors are loose.
