Property

649 Wood Dr.
Glenview, IL 60022

John Doe

02/01/2019 1:00 pm

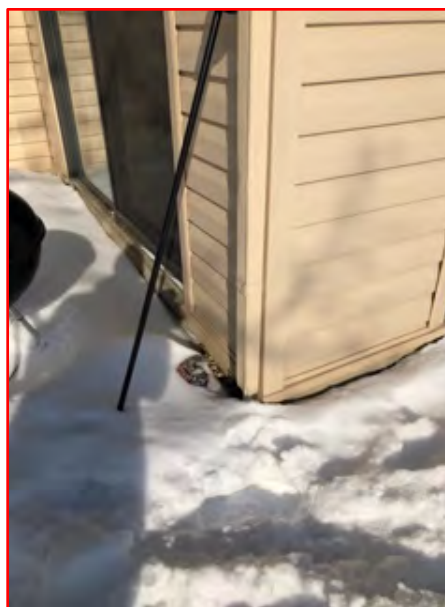
Figure 1-2

1) Downspouts should extend a min of 4-6' from the structure to reduce the risk of water penetration, settlement and structural damage. Evidence of water infiltration noted in crawlspace.

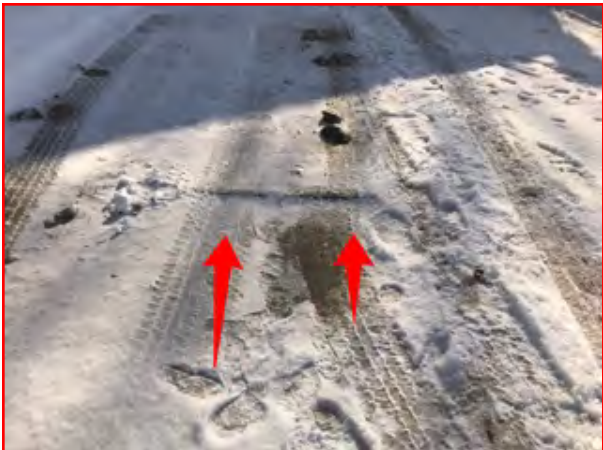
Figure 3-1

2) The driveway expansion joint that separates concrete slabs are not sealed properly. Resulting in movement of the slabs due to frost heaving and becoming a trip hazard.

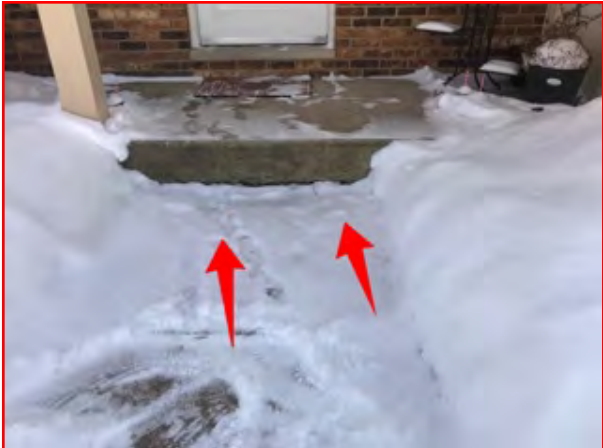
Figure 4-1

3) A negative grading in front walkway of the home is leading water towards the front stoop and foundation.

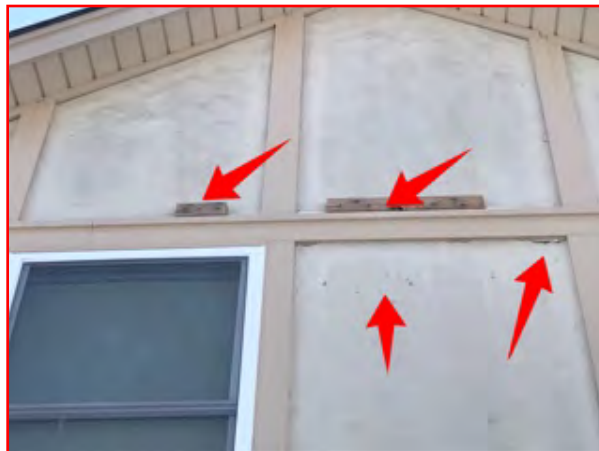
Figure 6-2

4) Damage to the front stucco and wood planks (2" x 4") are nailed to front stucco. We Recommend having a licensed professional to evaluate before closing. See attic section.

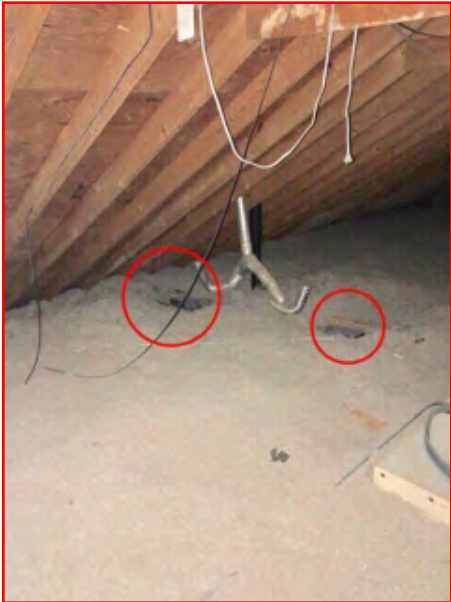
Figure 9-1

6) The bathroom exhaust vents have been detached from the ductwork. Bath vents should be ducted to the outdoors to reduce the risk of moisture and mold problems.

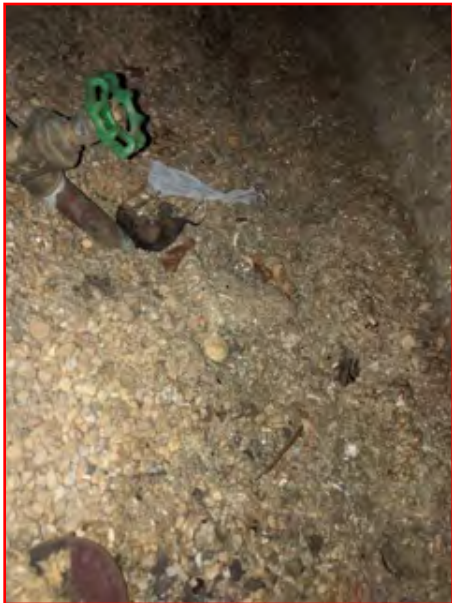
Figure 12-2

7) There is evidence of rodent activity. We recommend evaluation by a pest control professional.

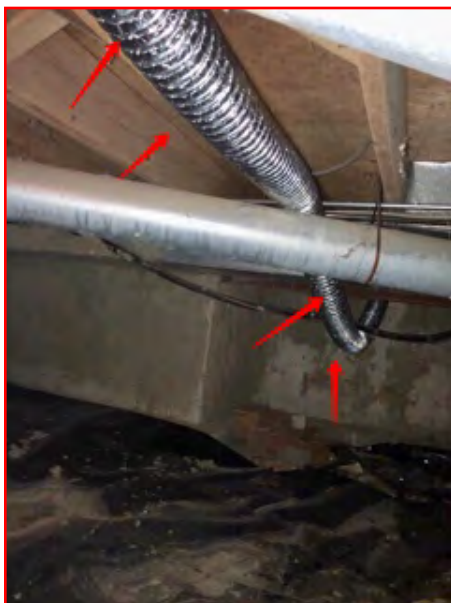
Figure 13-1

8) Dryer vents should have smooth metal interior to reduce the risk of lint buildup and allow for routine cleaning. Dryer lint is a combustible material. Dryer exhaust ducts should be kept clean for safety.

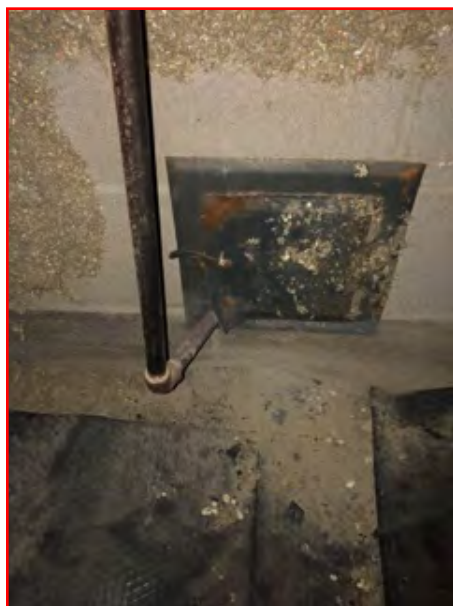
Figure 15-1

9) The gas line feeding the west fireplace has no accessible shutoff.

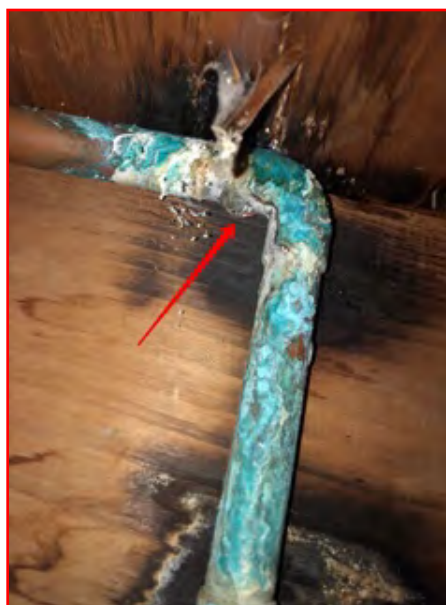
Figure 16-2

10) There is an active leak and heavy corrosion on a copper water supply pipe in the south central part of the crawlspace. We recommend all water supply fittings in the crawlspace be evaluated by a licensed plumber. Active leaks should be repaired promptly.

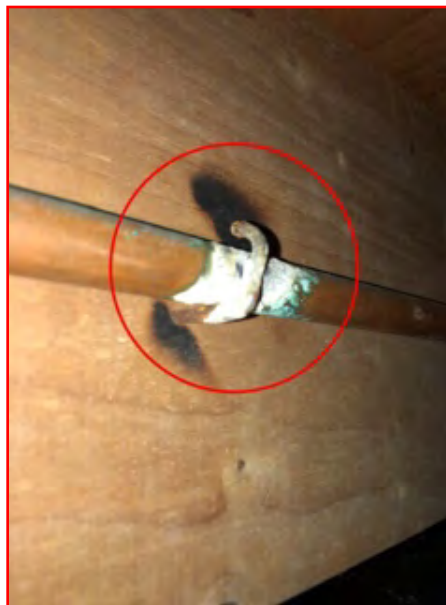
Figure 17-2

11) There is galvanic corrosion on the water pipes at numerous joints and fasteners. We recommend all visible water pipes be evaluated by a qualified plumber. Any improper hangers should be replaced with correct ones to reduce the risk of electrolysis and eventual leaks.

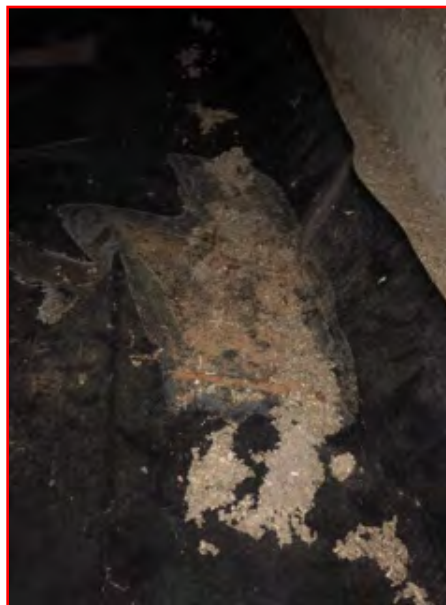
Figure 18-2

12) There are loose, poorly supported and uninsulated HVAC ducts in the crawlspace. Signs of water below ducts can indicate poor management of condensate runoff. We recommend ductwork be evaluated by a licensed HVAC professional. See comments on HVAC "distribution" section of report.

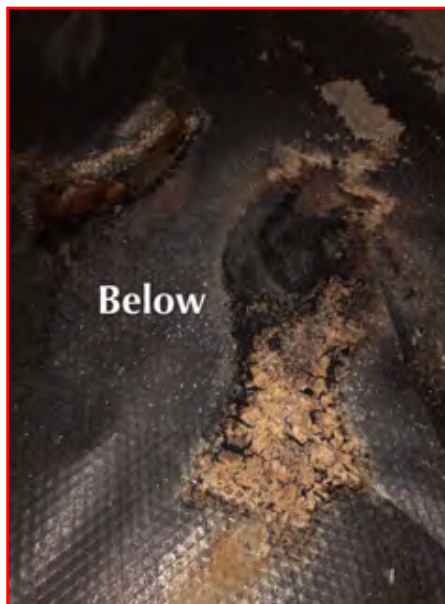
Figure 19-2

13) There is a leak at a union in the black waste line in the crawlspace. We recommend evaluation for repair by a qualified plumber.

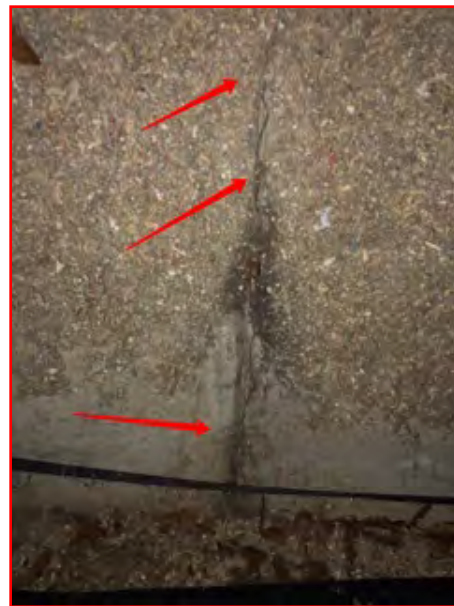
Figure 20-2

14) There are 3 or more cracks in the foundation. These should be evaluated for repair by a qualified basement waterproofing/structural professional.

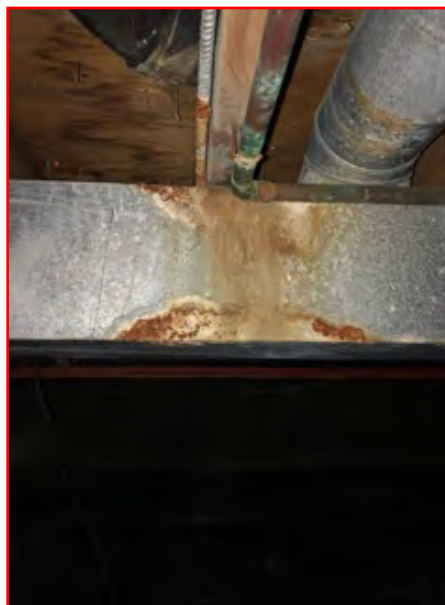
Figure 21-2

15) The main floor toilet is loose and leaking on to the HVAC ductwork below. We recommend repair by a qualified plumber and professional cleaning of the ductwork.

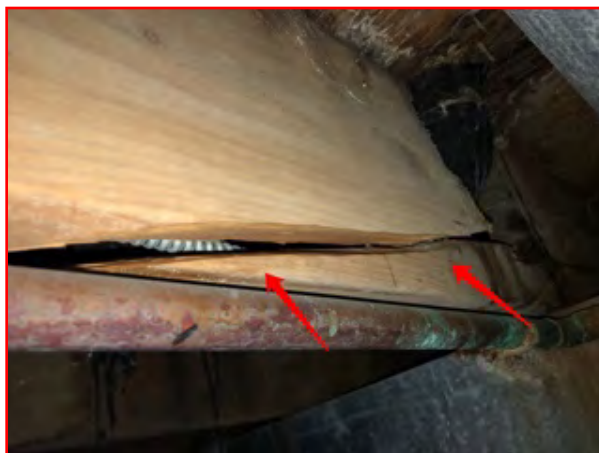
Figure 22-2

16) The joist below the main floor toilet has been improperly notched to accommodate the waste drain. The remaining joist has split through. This should be evaluated by a qualified building contractor prior to repairs of the toilet.

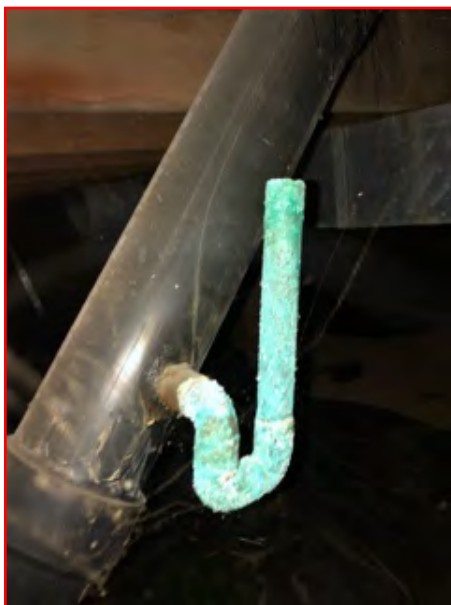
Figure 23-1

17) There is an incorrectly installed p-trap/vent in the main waste drain. This should be removed by a qualified plumber to prevent toxic sewer gasses from entering the crawlspace.

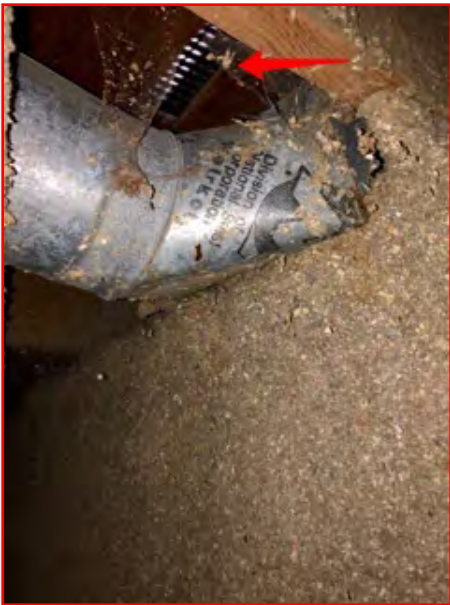
Figure 28-2

18) One of the supply ducts in the crawlspace is not correctly installed. Conditioned air is being supplied to the crawlspace rather than the kitchen heat register above. We recommend the ductwork in the crawl space be evaluated by a HVAC professional.

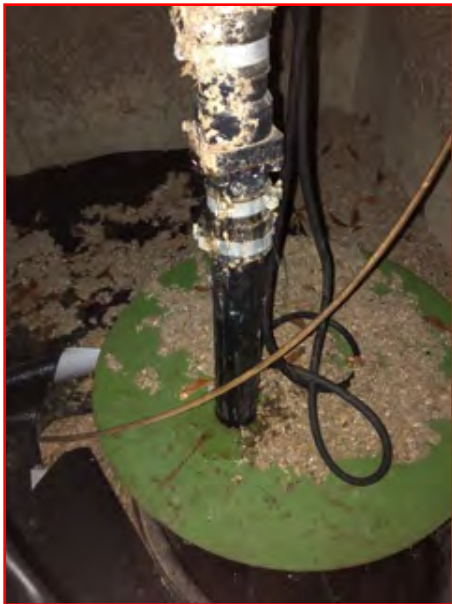
Figure 30-2

19) The check valve in the sump drain line is leaking.

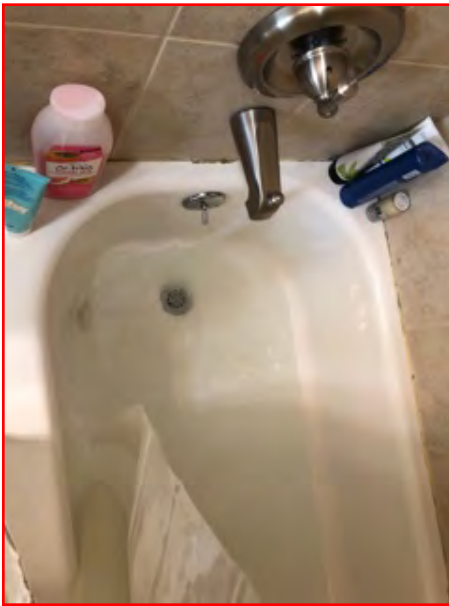
Figure 31-1

20) The drainage in the tub is not sufficient to keep up with the flow of water.

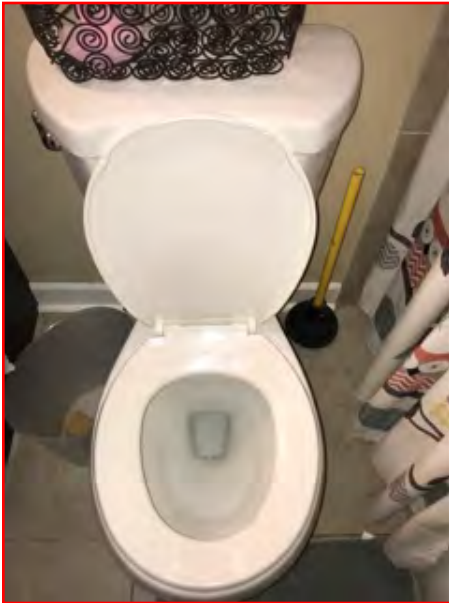
Figure 34-1

21) The toilet is loose at the floor and requires sealant at the base.

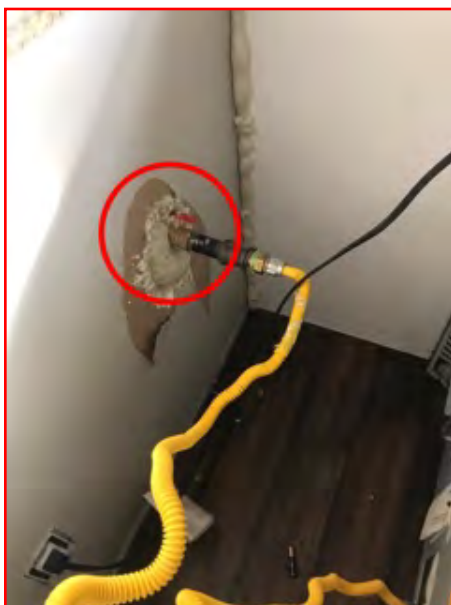
Figure 36-1

23) The shut off valve for the stove gas line is inoperable. The black pipe gas line is too long and obstructing the stove from seating flush.

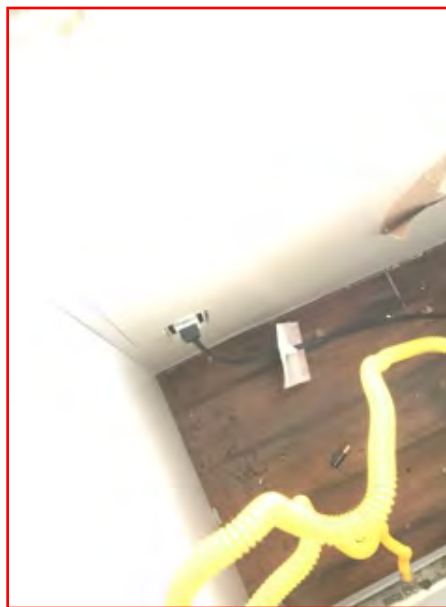
Figure 37-2

24) Signs of rodents /mice dropping behind the stove. Recommend having a licensed exterminator to evaluate.

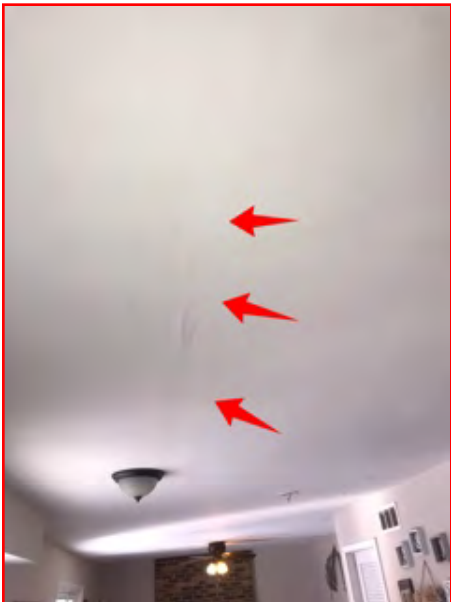
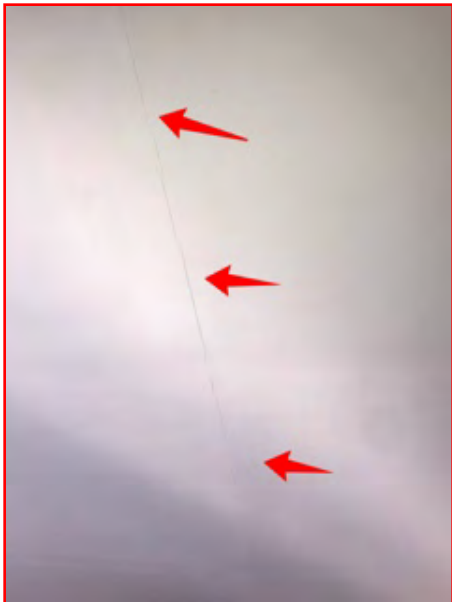
25) Settlement crack with signs of past moisture along the tapping of the ceiling drywall.

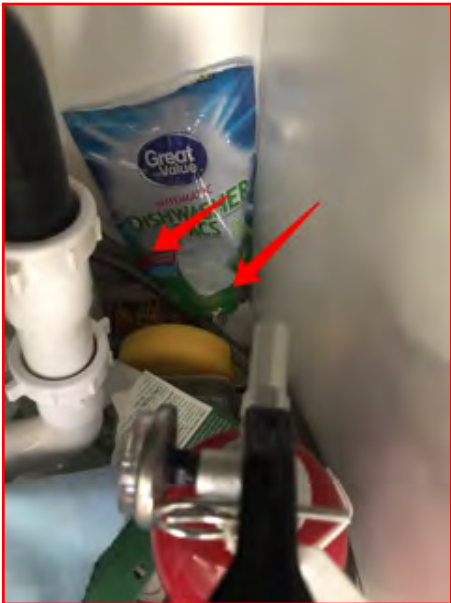
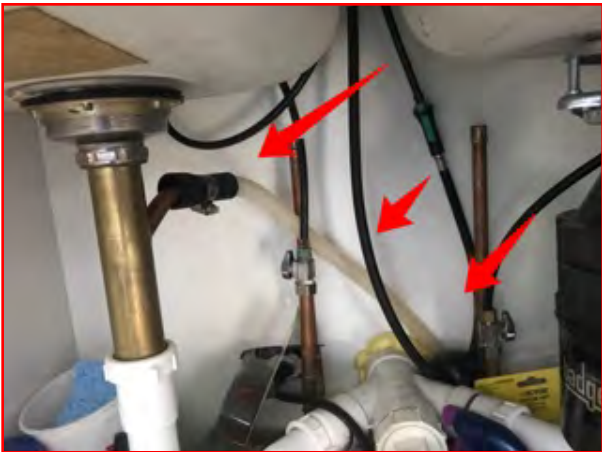
26) A high drain loop is needed to be installed 32" above the floor level or an air gap must be installed. To prevent a back flow of dirty water entering the dishwasher.

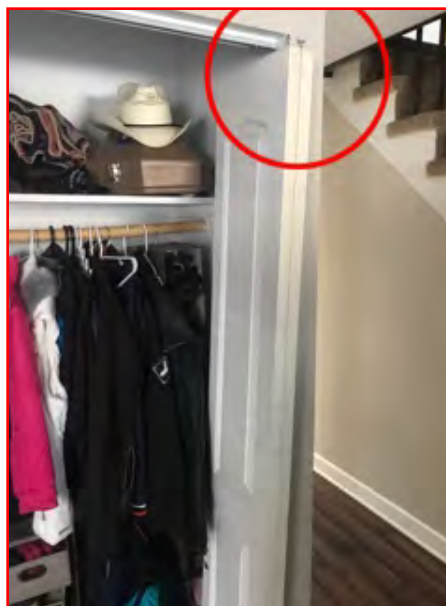
Figure 40-2

27) the closet folding doors are off their track and damaged.

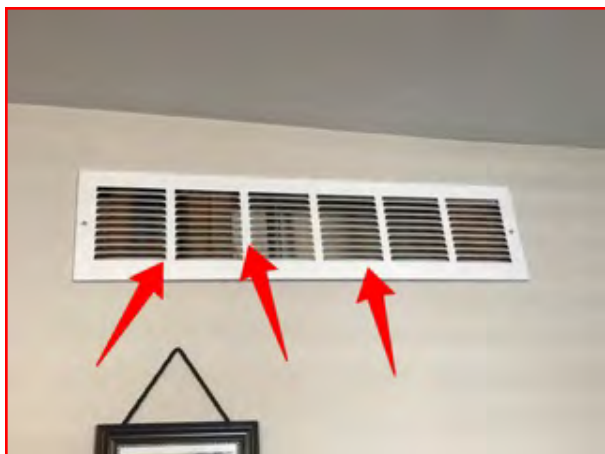
Figure 42-1

28) The return vent opening is larger than the vent, allowing heat to escape between the drywalls.

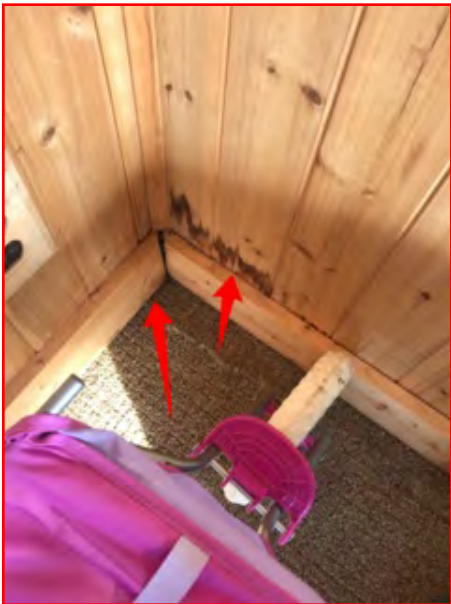
Figure 44-1

30) Signs of water penetration on the northeast side of the sun room.

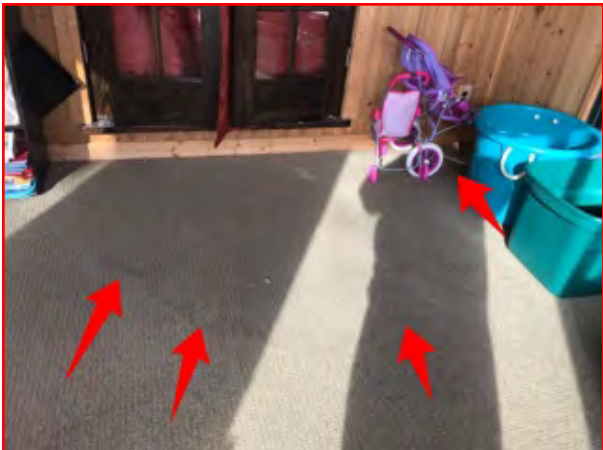
Figure 45-1

31) Signs of water penetration under the carpet of the sun room.

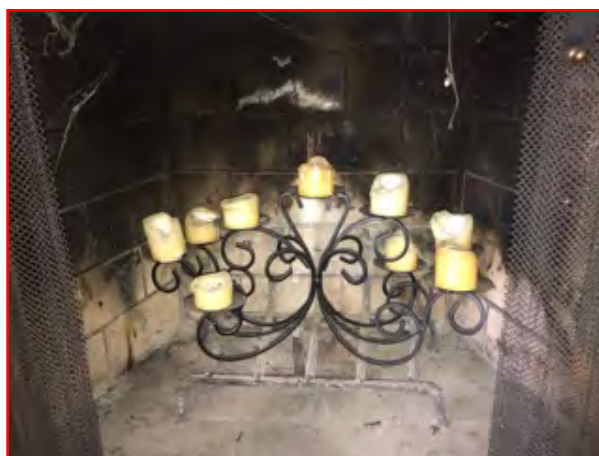
Figure 48-2

33) Recommend a professional to clean and evaluate the fireplace before usage. There is a build up of soot along the walls.

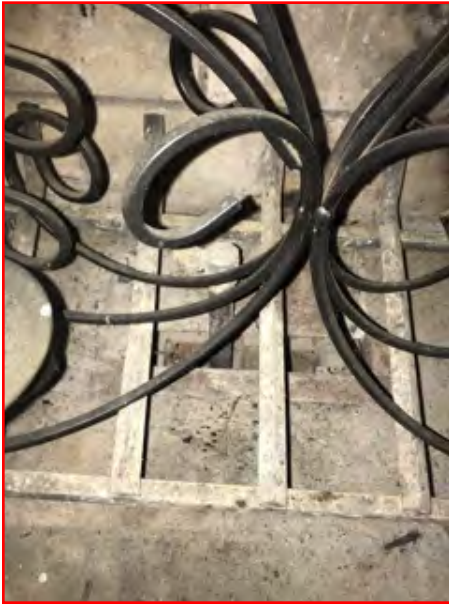
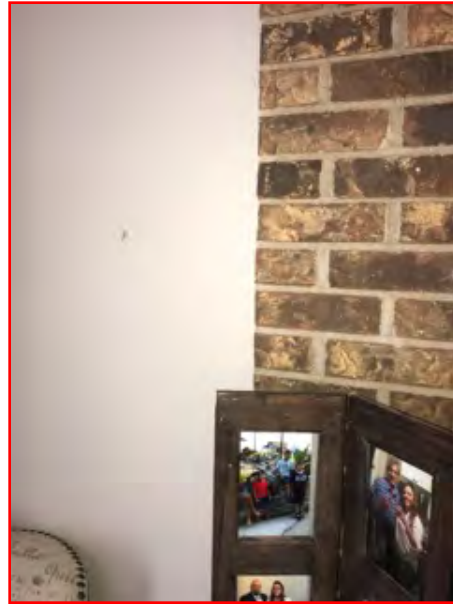
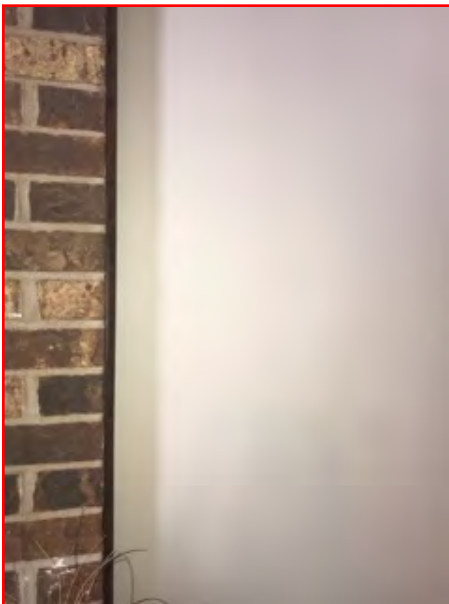
34) A gas supply pipe is installed with in the ash pit but no Gas Starter Access was discovered.

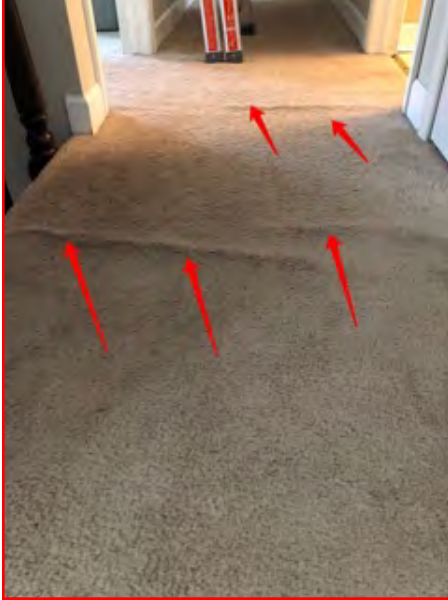
Figure 50-1

35) Bunched carpet at the top of the stairs is a potential trip hazard. The carpet should be re-stretched.

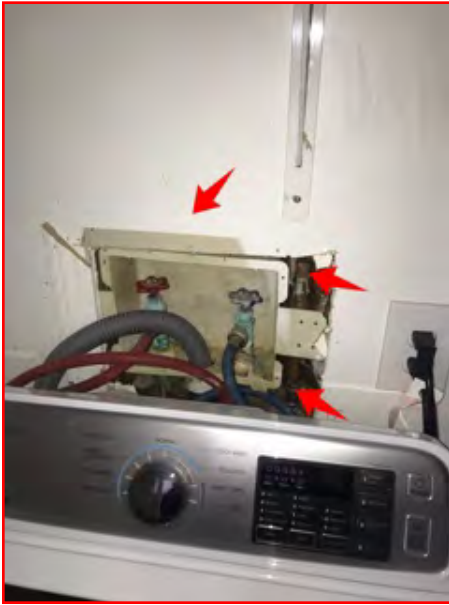
Figure 57-1

38) Framing and drywall around the laundry hook up is damaged and exposing pipes.

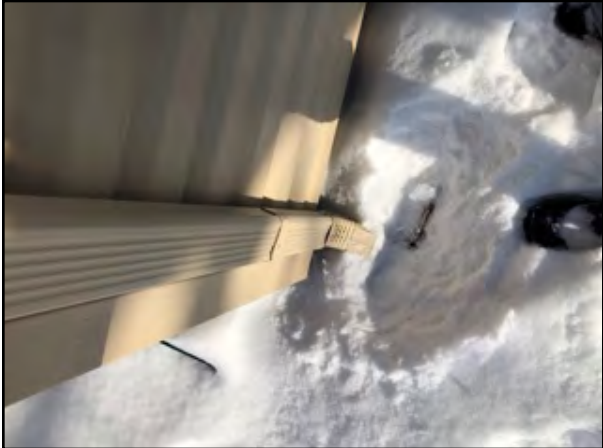
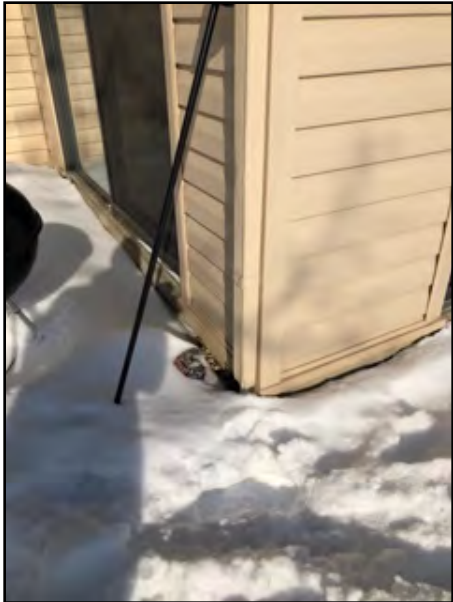
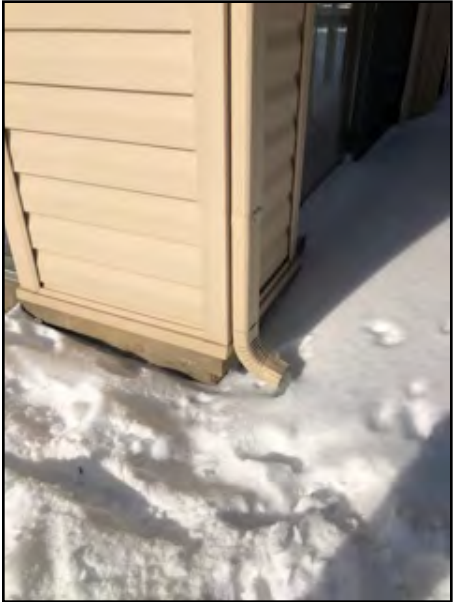
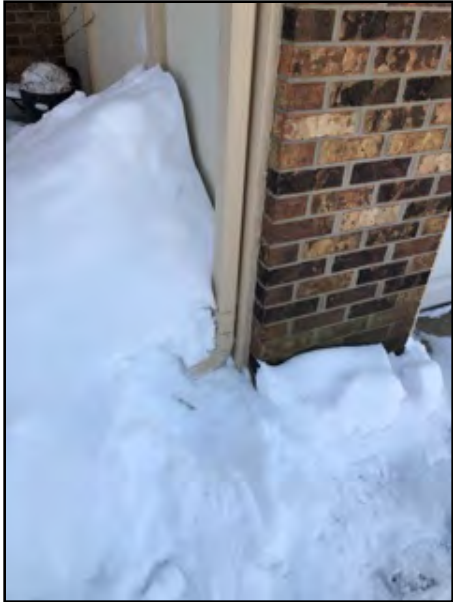
Downspouts should extend a min of 4-6' from the structure to reduce the risk of water penetration, settlement and structural damage. Evidence of water infiltration noted in crawlspace.

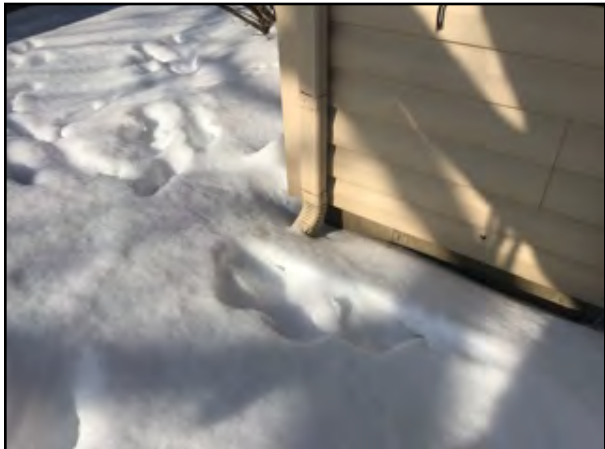
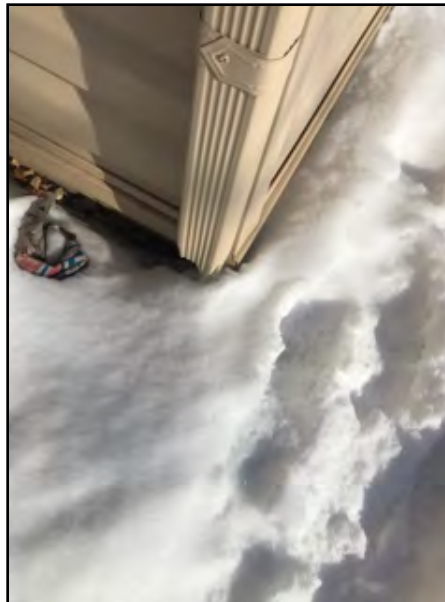
i Comment 2:
Downspout needs to be extended 6' away from the property to prevent water infiltrating the foundation.

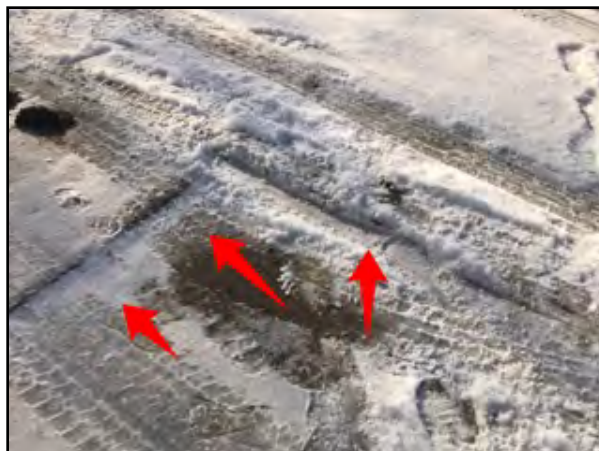
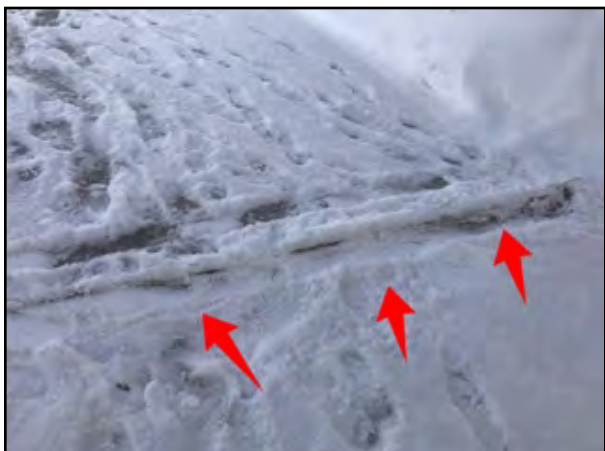
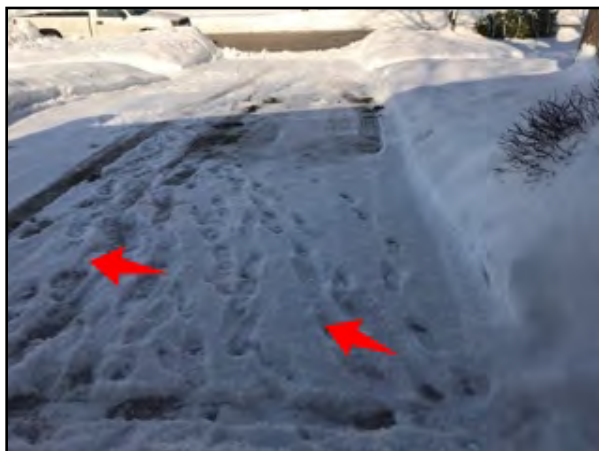
The driveway expansion joint that separates concrete slabs are not sealed properly. Resulting in movement of the slabs due to frost heaving and becoming a trip hazard.

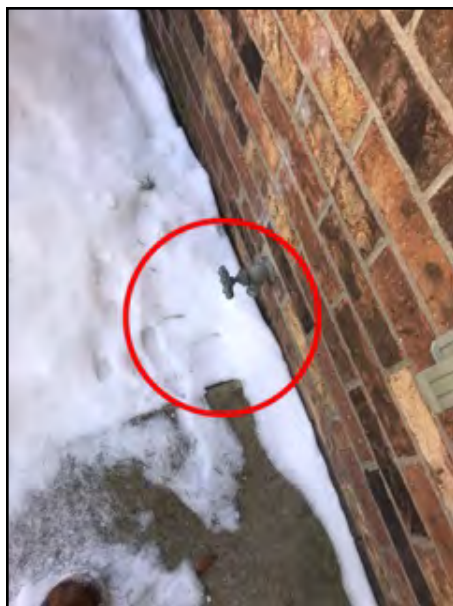
Figure 5-1

**Comment 5:**
No anti-siphon device discovered on spigots. This could lead to cross contamination.

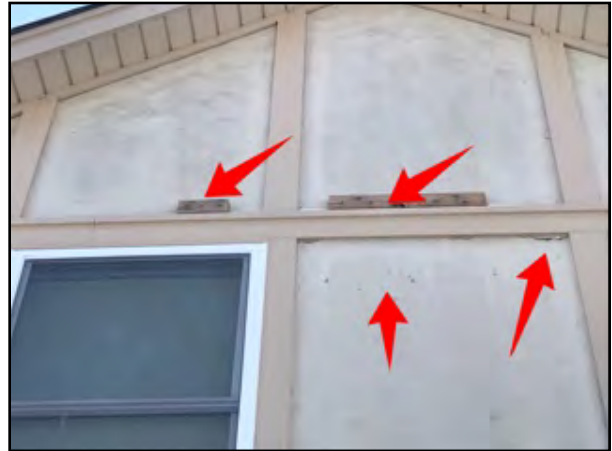
Figure 6-2

Damage to the front stucco and wood planks (2" x 4") are nailed to front stucco. We Recommend having a licensed professional to evaluate before closing. See attic section.

There is frost buildup on the front wall of the attic. Damage to the front exterior in this area has been temporarily repaired with 2x4 boards. We recommend the front of the home and this section of attic be evaluated for repair by a qualified building contractor to prevent further water damage.

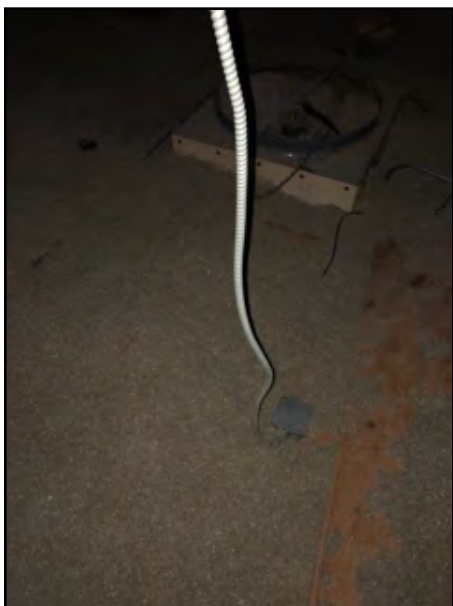
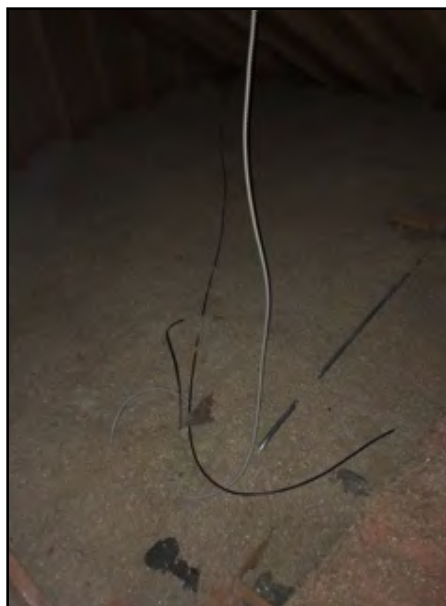
Electrical wires should be supported by proper hangers.

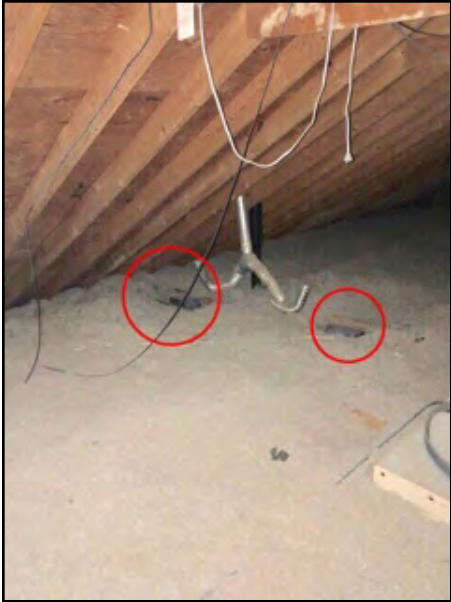
Figure 9-1

The bathroom exhaust vents have been detached from the ductwork. Bath vents should be ducted to the outdoors to reduce the risk of moisture and mold problems.

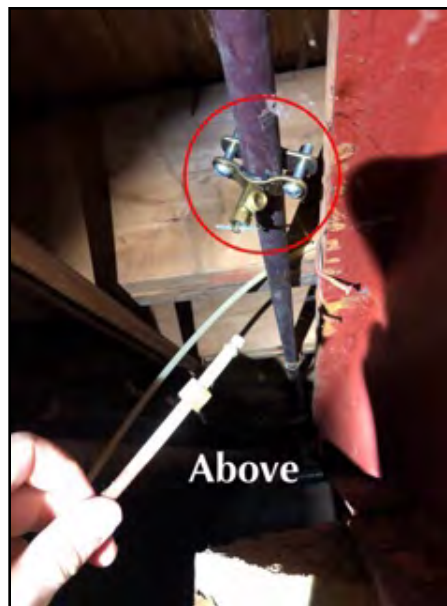
Figure 10-2

There is a saddle valve that is not in use. Saddle valves are commonly used for refrigerator ice maker water supply but they are inherently unreliable. There is evidence of past water leaks below. Area was dry at the time of the inspection.

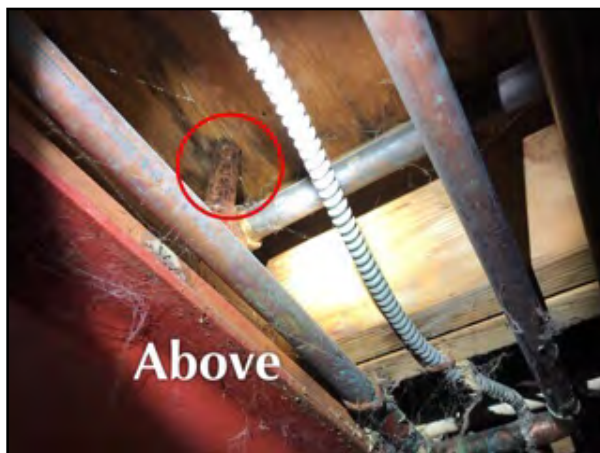
Figure 11-2

There is a rusty gas pipe and evidence of a past water leak. Dry when inspected.

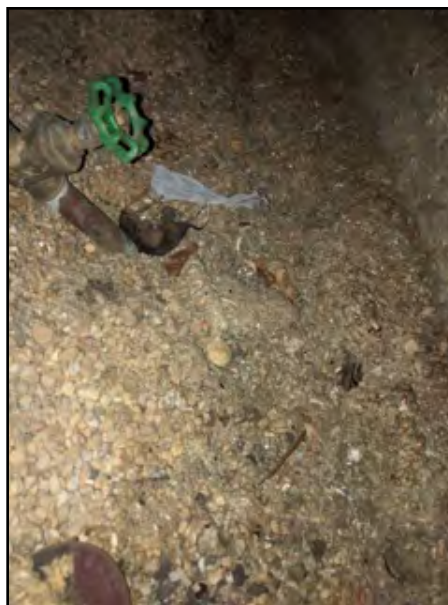
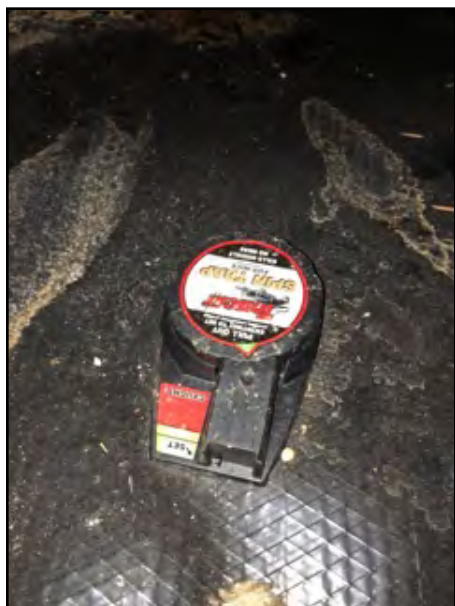
There is evidence of rodent activity. We recommend evaluation by a pest control professional.

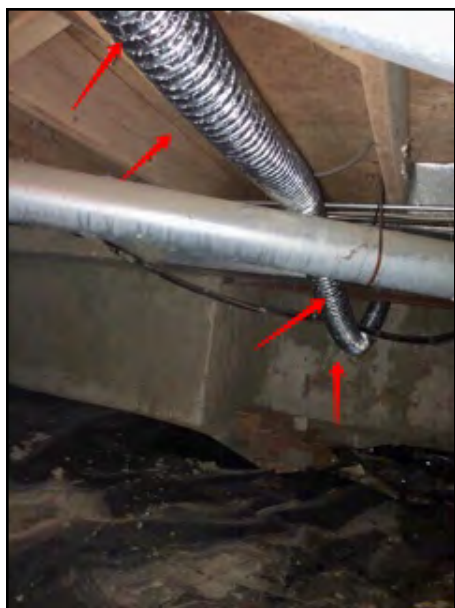
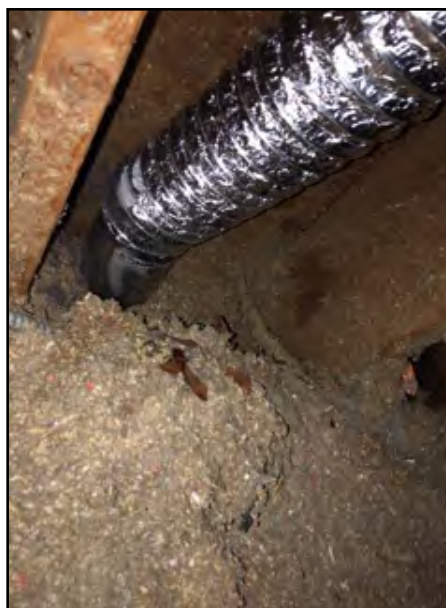
Dryer vents should have smooth metal interior to reduce the risk of lint buildup and allow for routine cleaning. Dryer lint is a combustible material. Dryer exhaust ducts should be kept clean for safety.

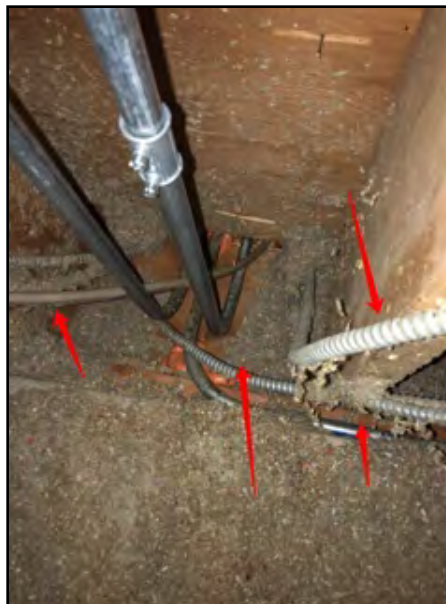
Figure 14-2

There are lengths of armored (BX) electrical wires that are not properly supported. We recommend electrical branch wiring in the crawlspace be evaluated by a qualified electrician.

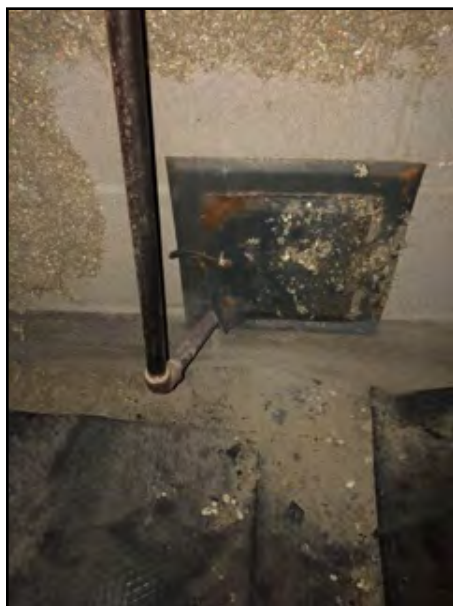
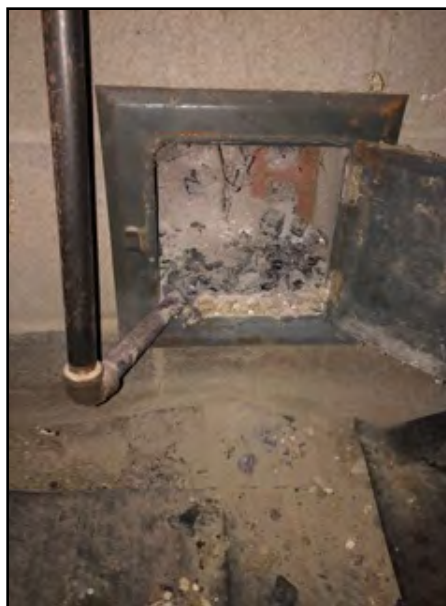
The gas line feeding the west fireplace has no accessible shutoff.

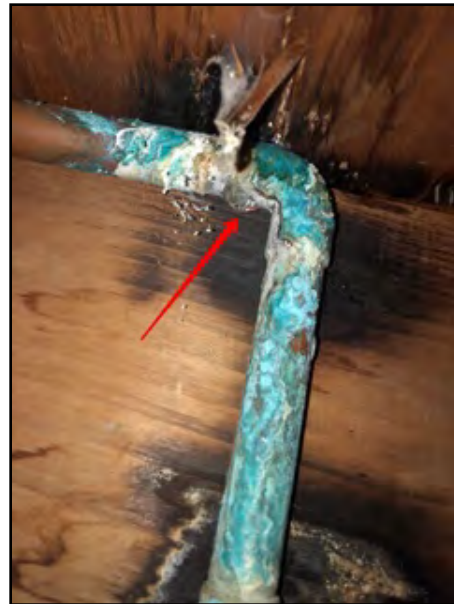
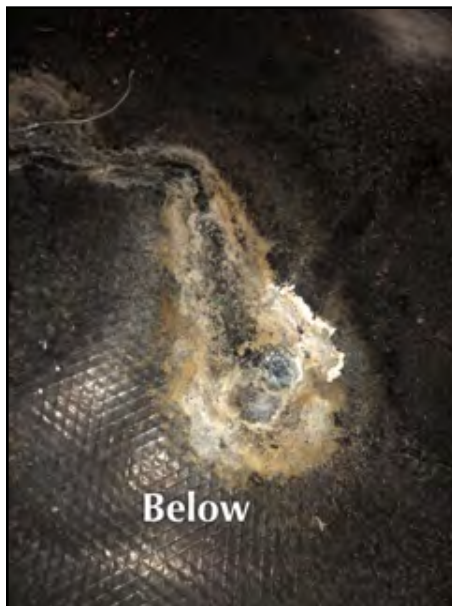
There is an active leak and heavy corrosion on a copper water supply pipe in the south central part of the crawlspace. We recommend all water supply fittings in the crawlspace be evaluated by a licensed plumber. Active leaks should be repaired promptly.

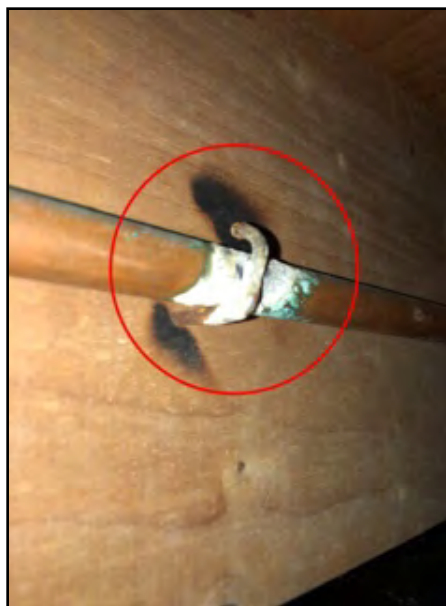
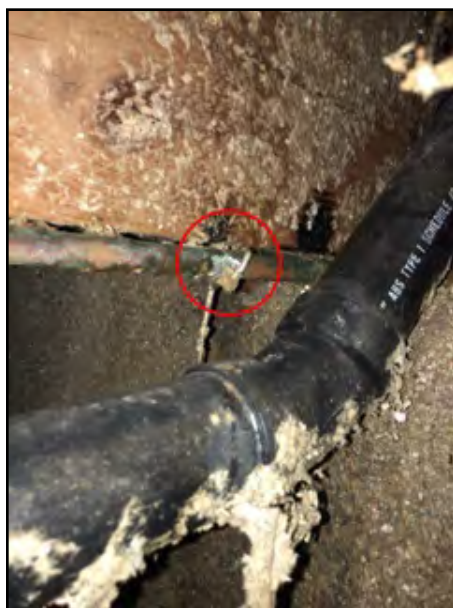
There is galvanic corrosion on the water pipes at numerous joints and fasteners. We recommend all visible water pipes be evaluated by a qualified plumber. Any improper hangers should be replaced with correct ones to reduce the risk of electrolysis and eventual leaks.

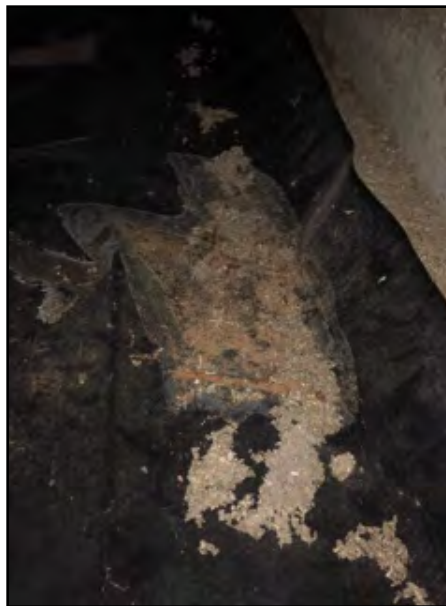
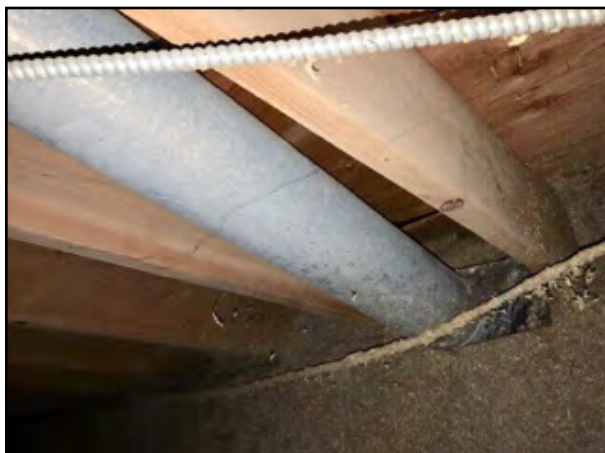
There are loose, poorly supported and uninsulated HVAC ducts in the crawlspace. Signs of water below ducts can indicate poor management of condensate runoff. We recommend ductwork be evaluated by a licensed HVAC professional. See comments on HVAC "distribution" section of report.

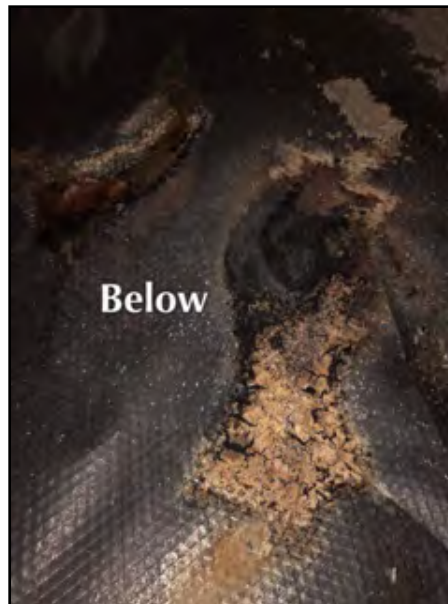
Figure 19-2

There is a leak at a union in the black waste line in the crawlspace. We recommend evaluation for repair by a qualified plumber.

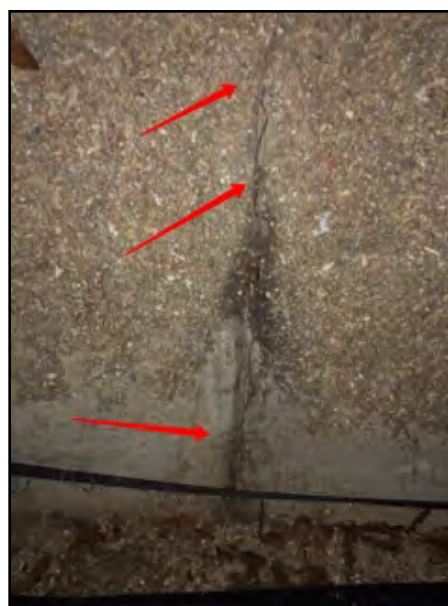
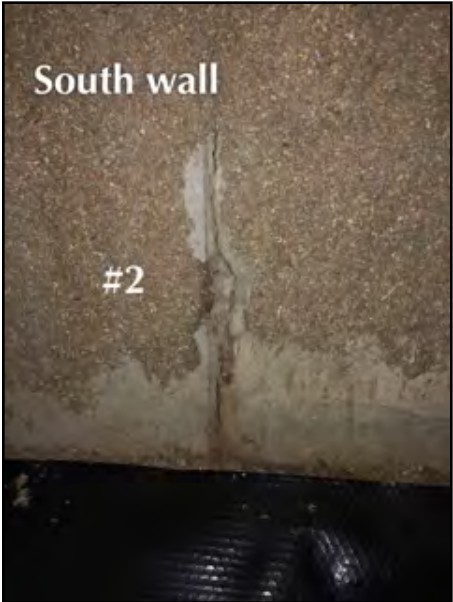
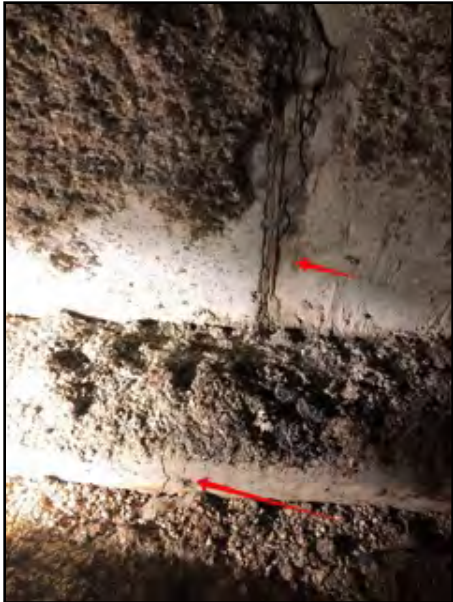
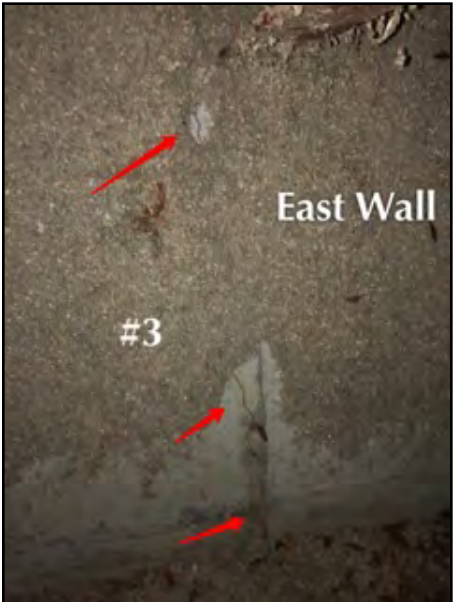
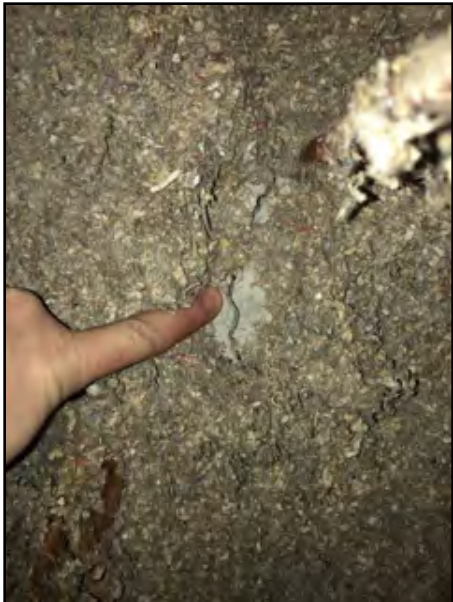
There are 3 or more cracks in the foundation. These should be evaluated for repair by a qualified basement waterproofing/structural professional.

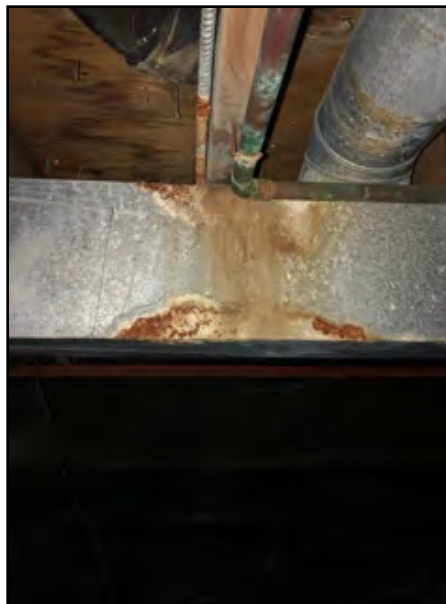
Figure 21-2

The main floor toilet is loose and leaking on to the HVAC ductwork below. We recommend repair by a qualified plumber and professional cleaning of the ductwork.

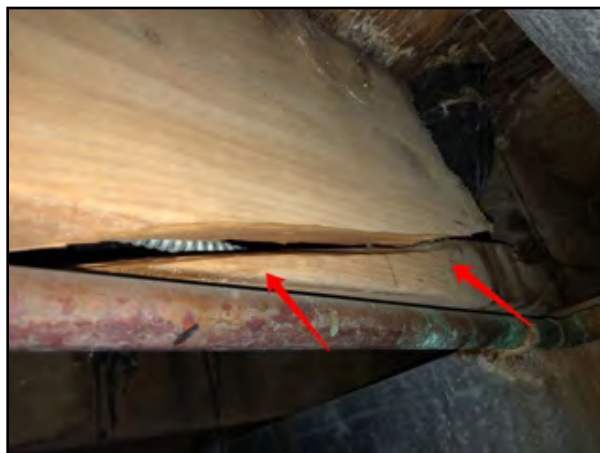
Figure 22-2

The joist below the main floor toilet has been improperly notched to accommodate the waste drain. The remaining joist has split through. This should be evaluated by a qualified building contractor prior to repairs of the toilet.

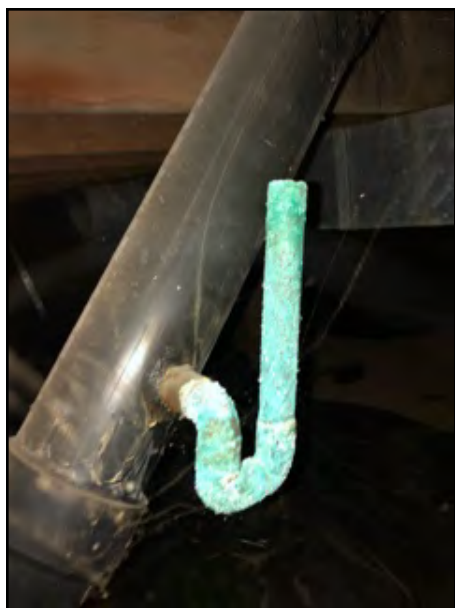
Figure 23-1

There is an incorrectly installed p-trap/vent in the main waste drain. This should be removed by a qualified plumber to prevent toxic sewer gasses from entering the crawlspace.

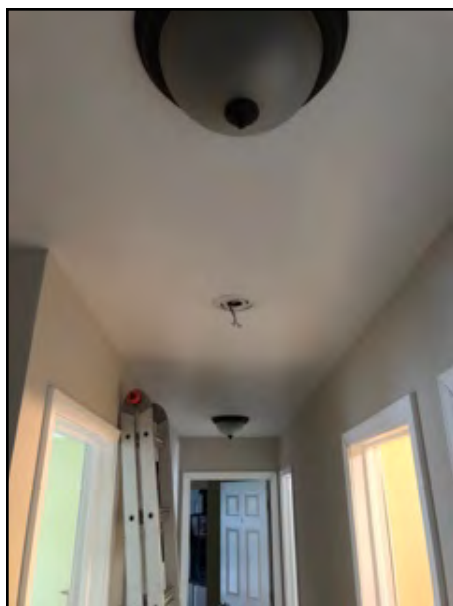
Figure 27-1

The upper hall has no smoke or CO detector.

Carbon monoxide and smoke detectors are required in every home and new detectors should be installed at the time of closing.
