Property

649 Wood Dr.
Glenview, IL 60022

John Doe

02/01/2019 1:00 pm

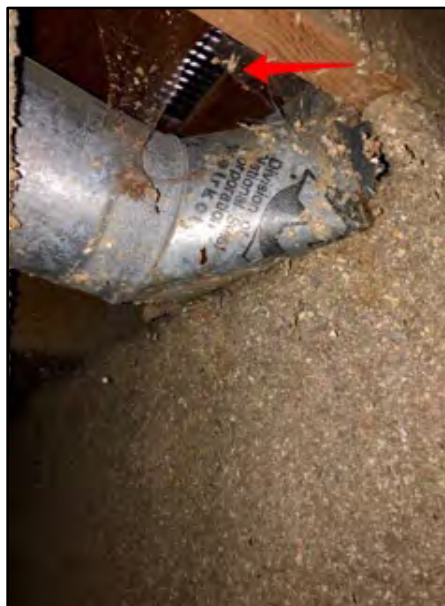
Figure 28-2

One of the supply ducts in the crawlspace is not correctly installed. Conditioned air is being supplied to the crawlspace rather than the kitchen heat register above. We recommend the ductwork in the crawl space be evaluated by a HVAC professional.

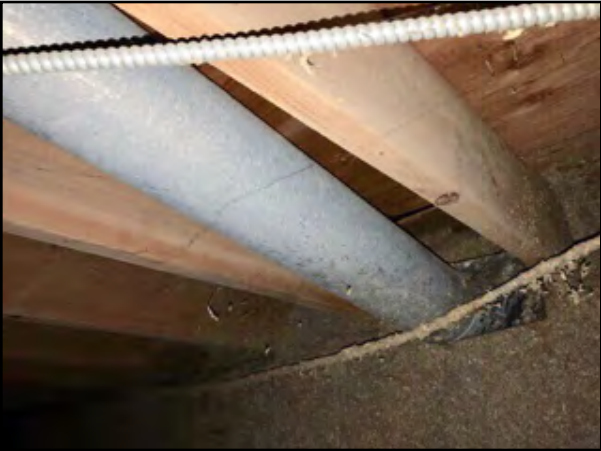
Figure 29-1

Recommend ductwork in all unconditioned spaces be insulated for a more efficient distribution.

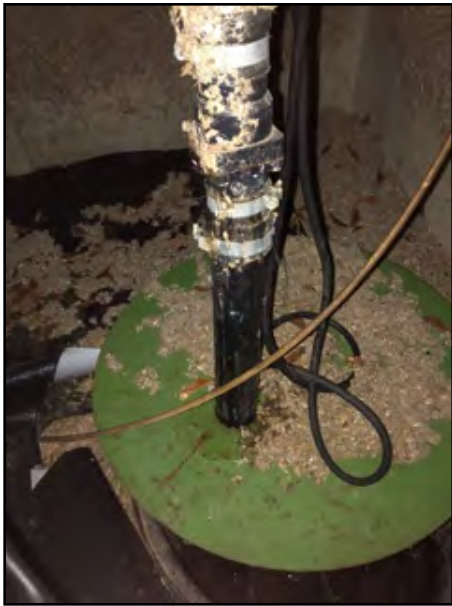
Figure 30-2

Comment 30:
The check valve in the sump drain line is leaking.

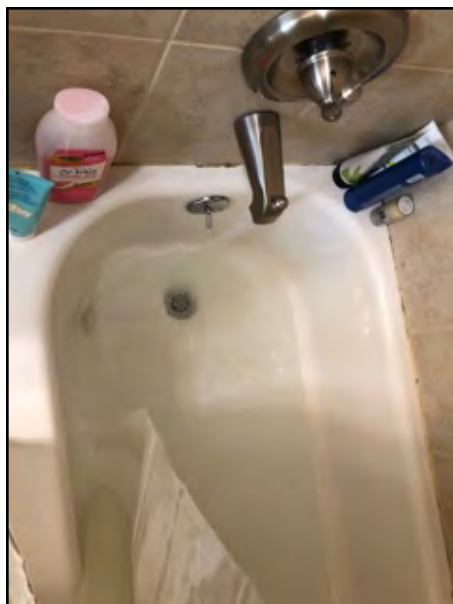
Figure 31-1

The drainage in the tub is not sufficient to keep up with the flow of water.

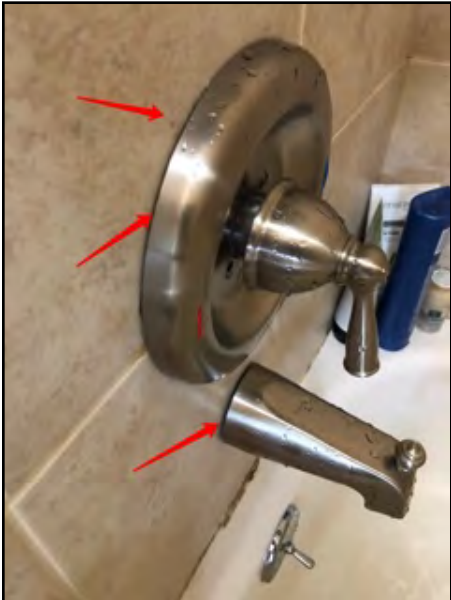
Figure 32-1

Gaps in the shower wall should be sealed with a proper silicone caulk to prevent water damage behind the wall.

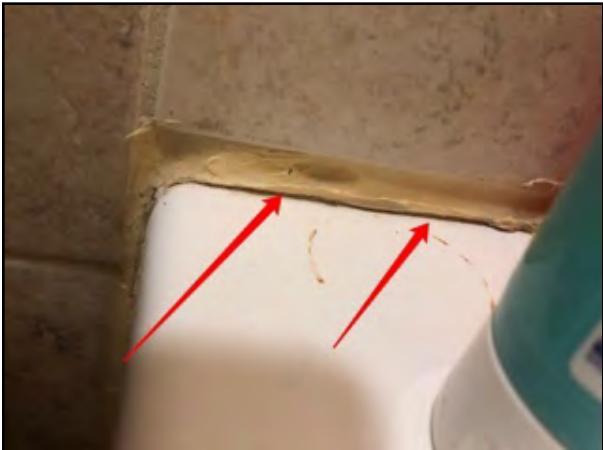
Figure 33-1

Comment 33:
There is failing caulk where the tub meets the wall.

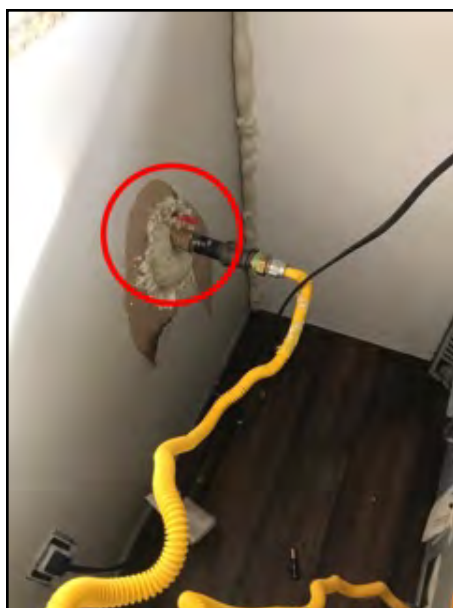
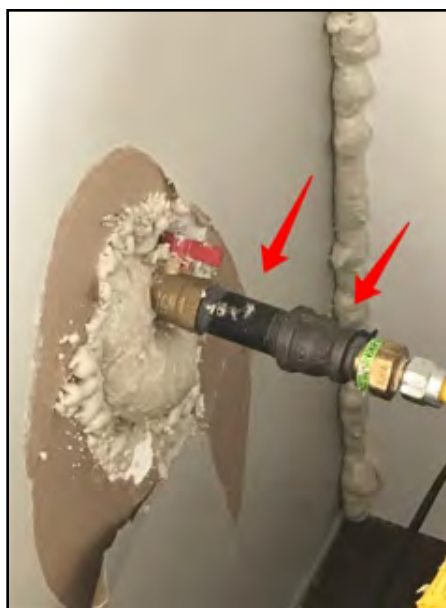
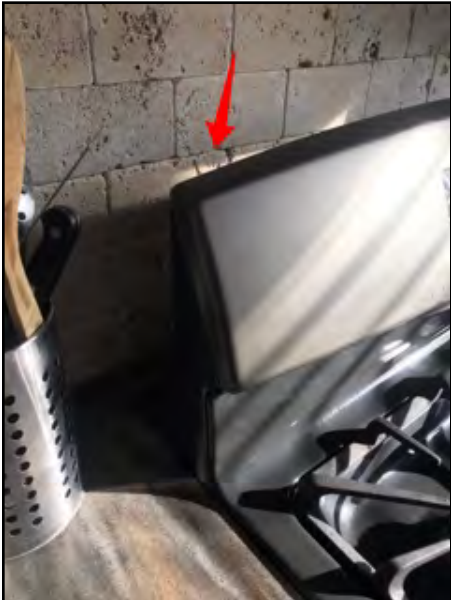
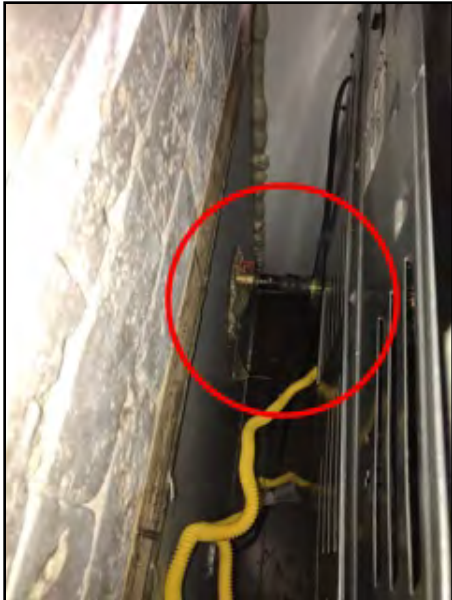
Comment 36:

The shut off valve for the stove gas line is inoperable. The black pipe gas line is too long and obstructing the stove from seating flush.

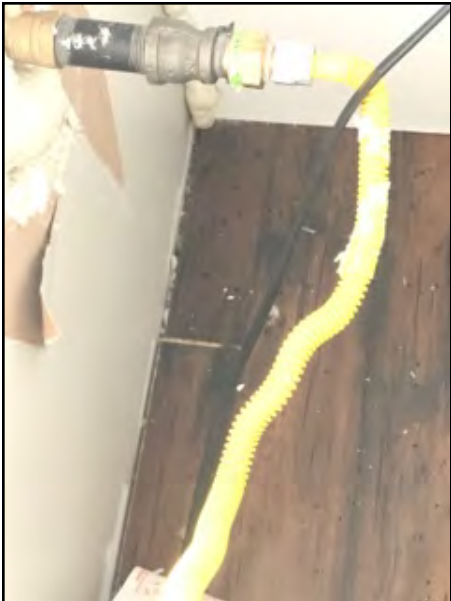
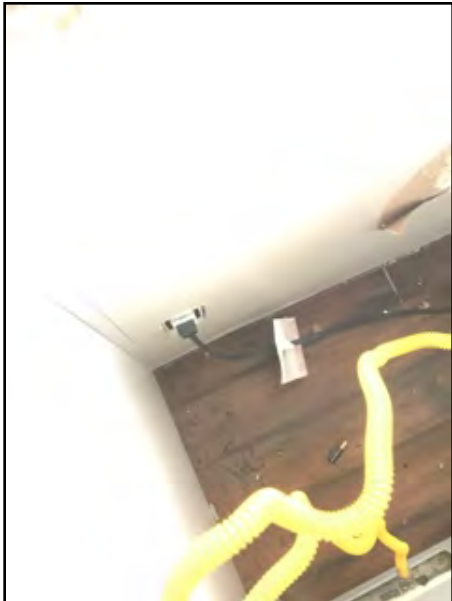
Comment 37:

Signs of rodents /mice dropping behind the stove. Recommend having a licensed exterminator to evaluate.

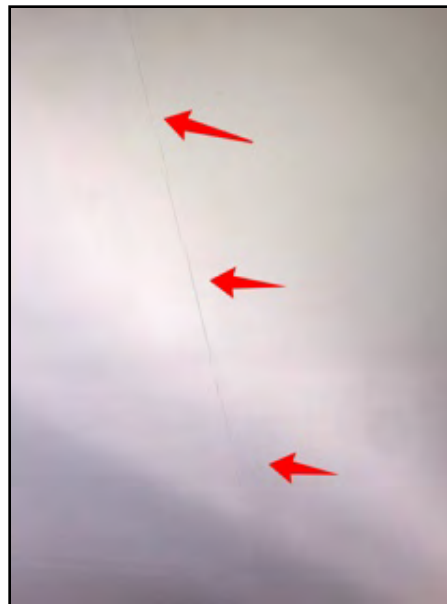
Figure 38-2

**Comment 38:**
Settlement crack with signs of past moisture along the tapping of the ceiling drywall.

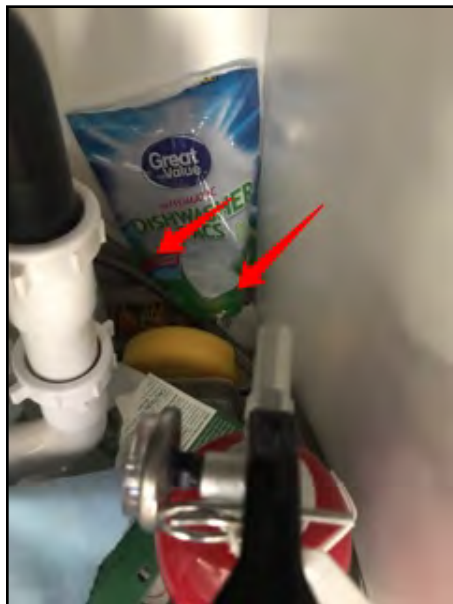
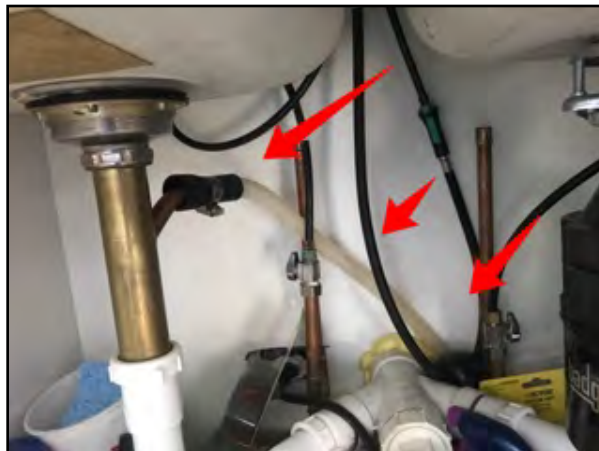
Comment 39:

A high drain loop is needed to be installed 32" above the floor level or an air gap must be installed. To prevent a back flow of dirty water entering the dishwasher.

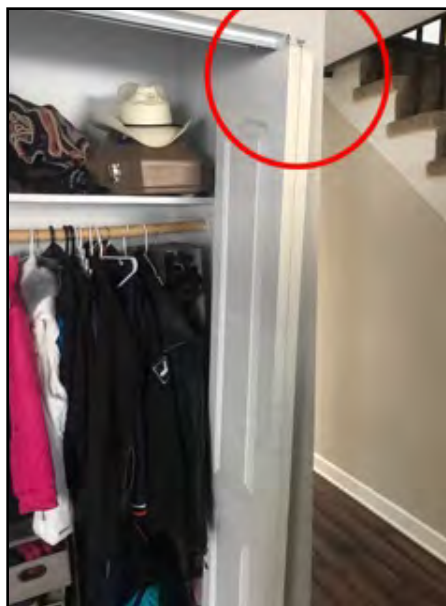
Figure 40-2

Comment 40:
the closet folding doors are off their track and damaged.

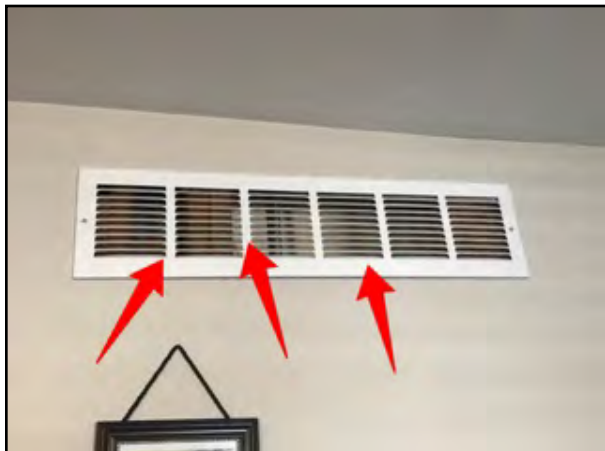
Figure 42-1

The return vent opening is larger than the vent, allowing heat to escape between the drywalls.

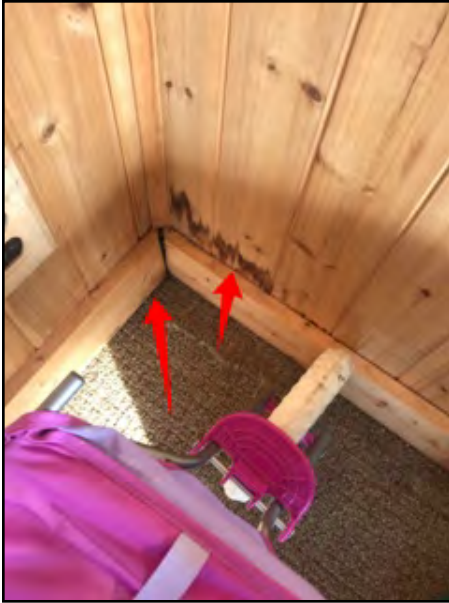
Figure 44-1

Comment 44:
Signs of water penetration on the northeast side of the sun room.

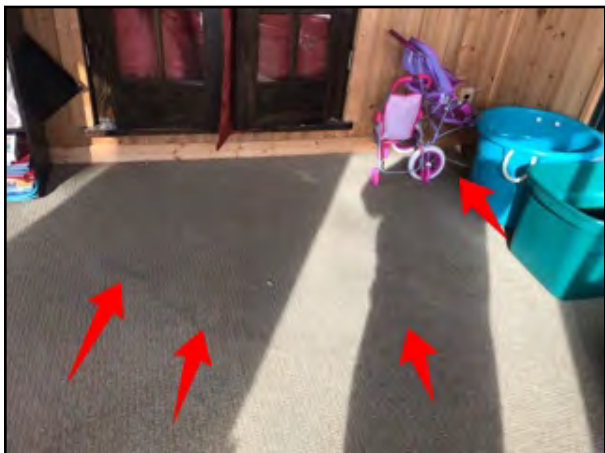
Figure 45-1

Signs of water penetration under the carpet of the sun room.

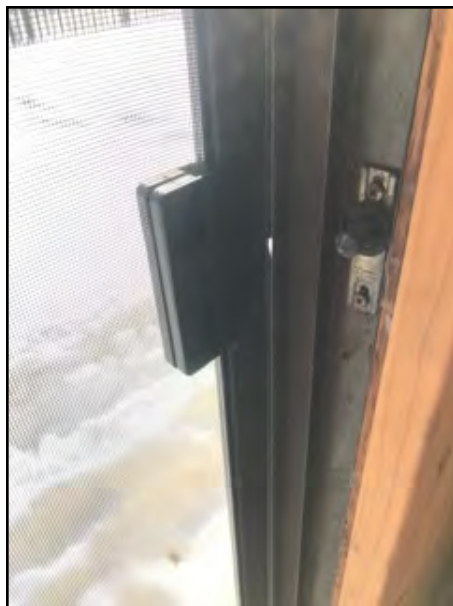
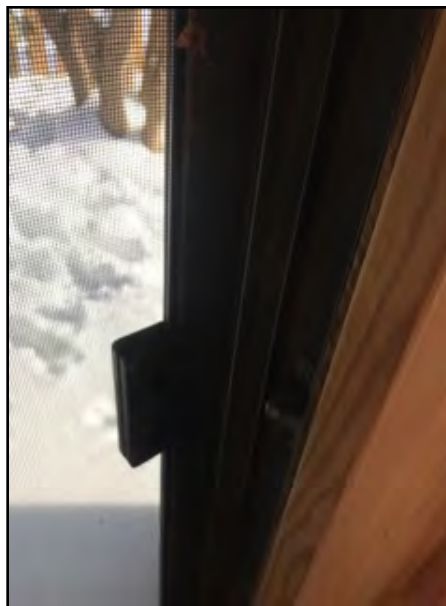
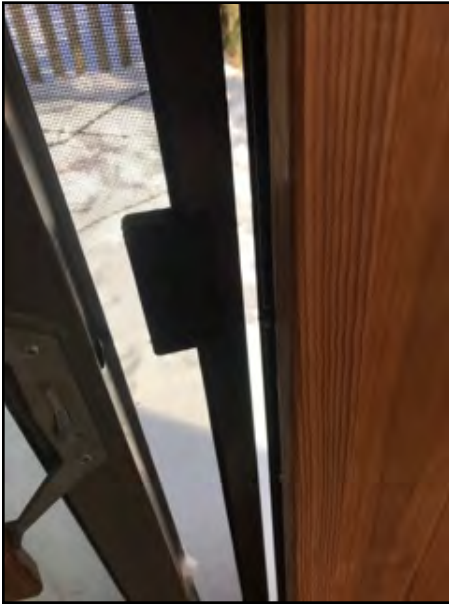
Comment 46:

All three sliding screen doors do not latch.

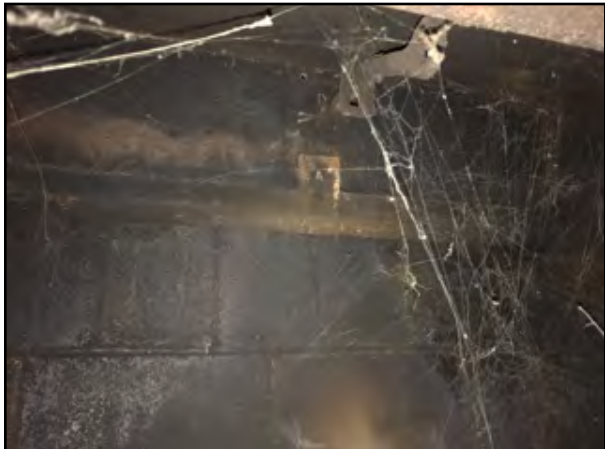
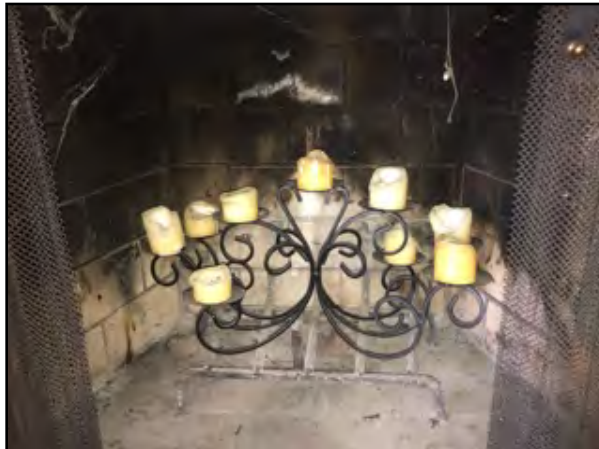
Comment 48:

Recommend a professional to clean and evaluate the fireplace before usage. There is a build up of soot along the walls.

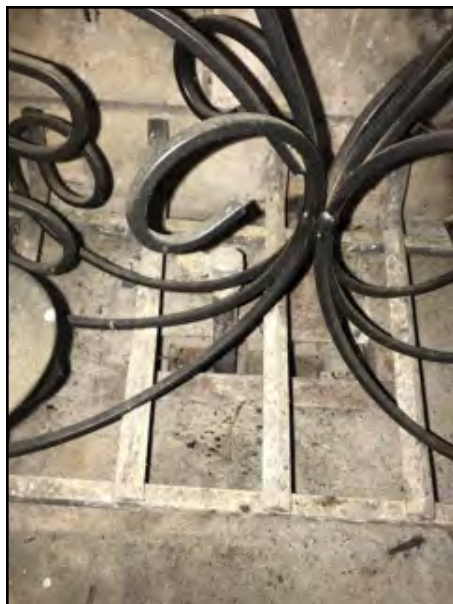
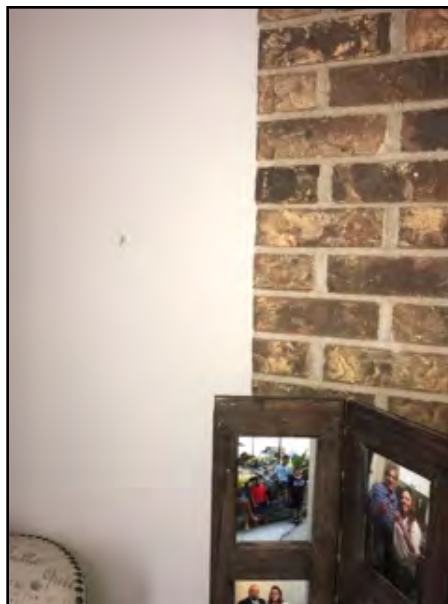
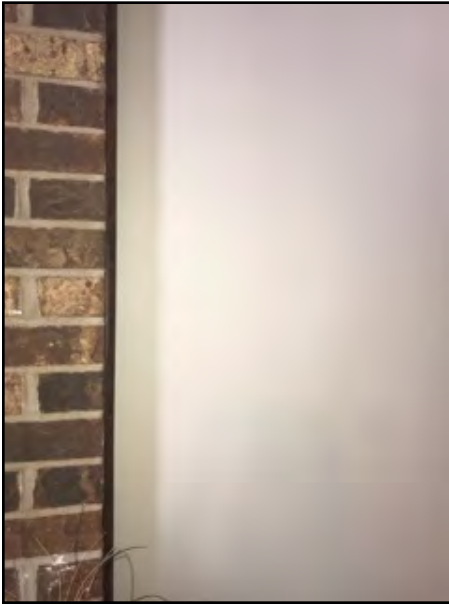
Comment 49:

A gas supply pipe is installed with in the ash pit but no Gas Starter Access was discovered.

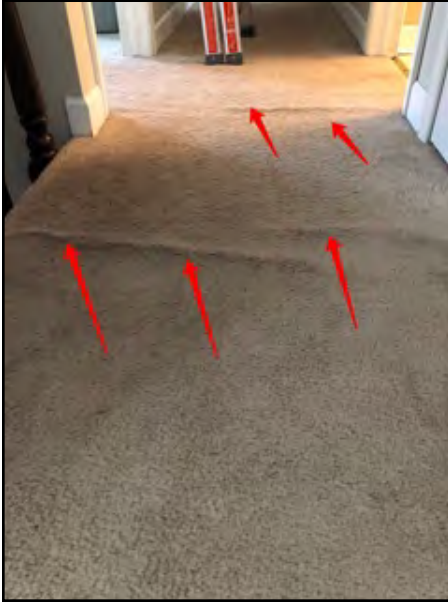
Figure 50-1

Bunched carpet at the top of the stairs is a potential trip hazard. The carpet should be re-stretched.

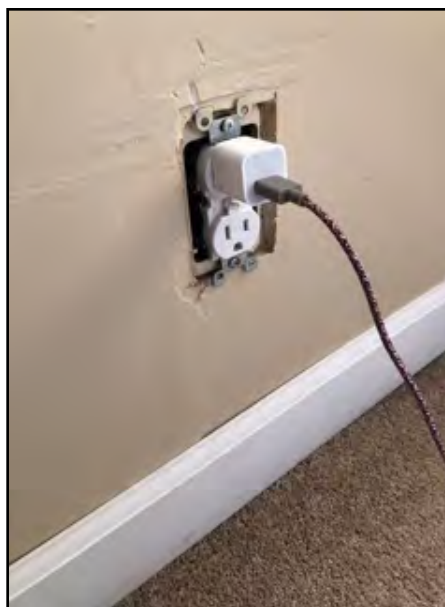
Figure 52-2

Comment 52:
There are missing switch plates.

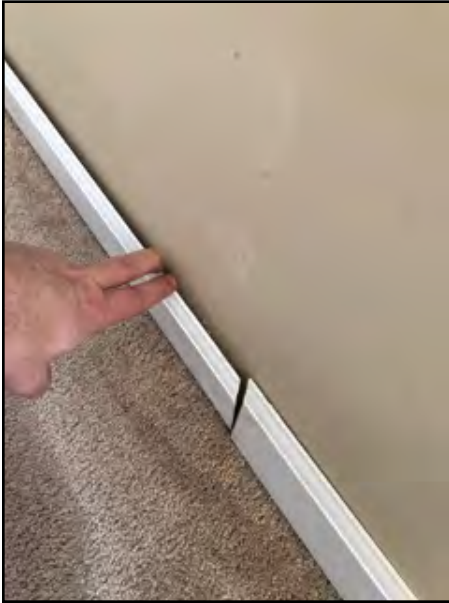
Figure 53-1

Comment 53:
The baseboards are loose.

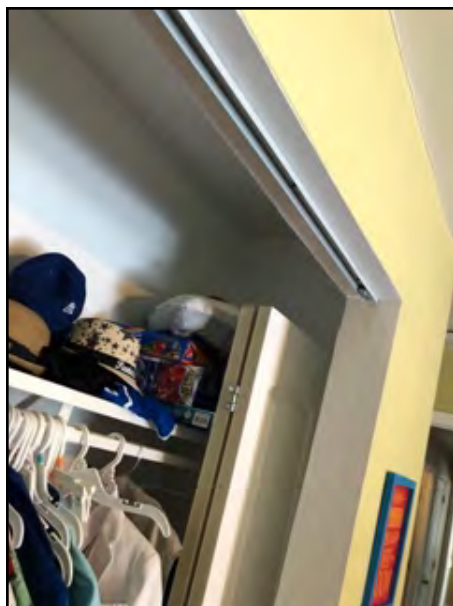
Figure 54-1

Comment 54:
The closet doors need to be re-hung.

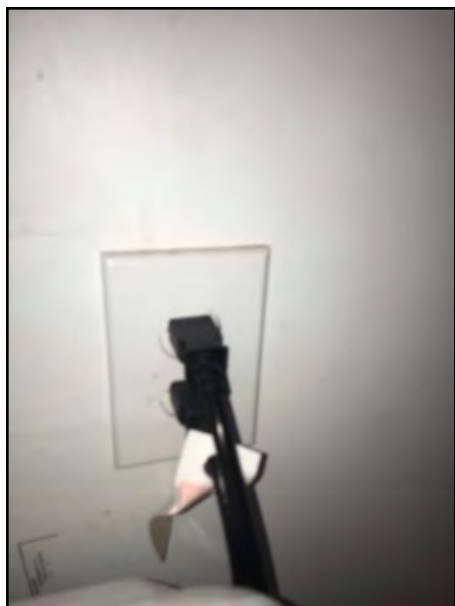
Figure 56-1

Comment 56:
Ground fault circuit interrupter (GFCI) outlets needed in laundry area.

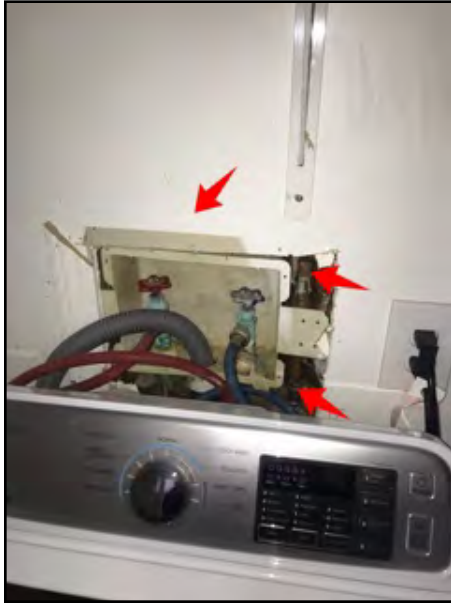
Figure 57-1

Comment 57:

Framing and drywall around the laundry hook up is damaged and exposing pipes.
